# Lashing Bar Tongue Separation

## Safety Alert - Feb 2022

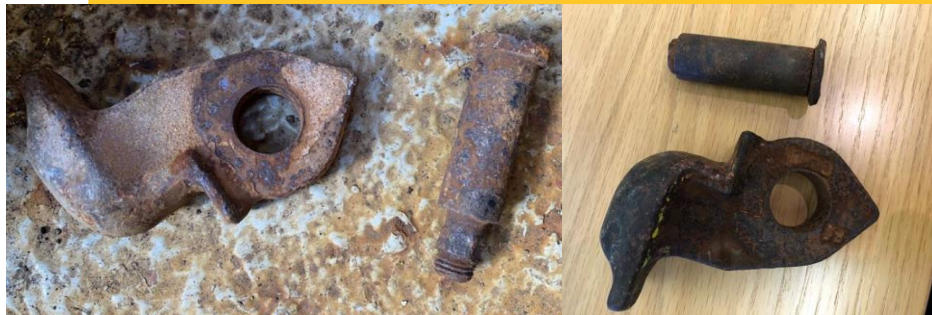
Recently Group SSE received reports of Lashing Bar Tongues separating from the lashing bar and falling onto the deck, narrowly missing the stevedores.

The failures have occurred where the nut has unwound from the bolt, or the pin has failed due to wear and tear and lack of maintenance. Fortunately, these events were near misses only, which we can learn from. The purpose of this Alert is to ensure workers are aware of this potential risk and complete the necessary inspections and reporting. We believe these types of lashing bar failures are rare (although the consequence could be serious) however over three days, the same deficiency was identified on two different vessels, which were issued with deficiency notices.
