HEALTH AND SAFETY ALERT**Hatch Foreman fractures elbow after tripping over on vessel**

Incident no: 1974

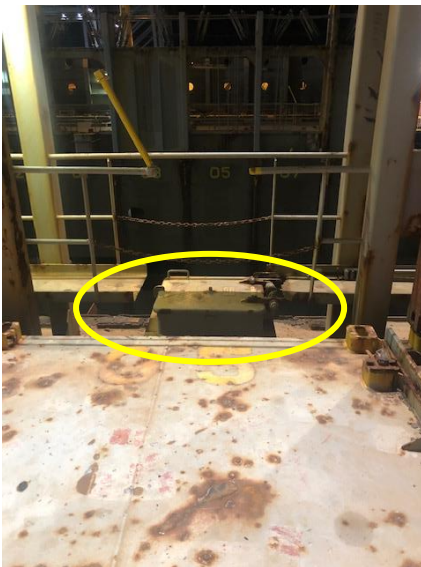
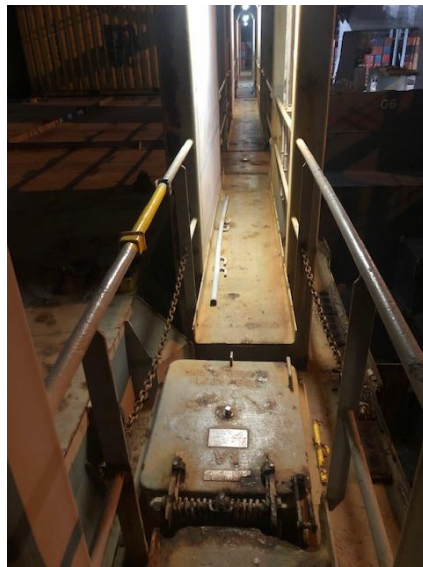
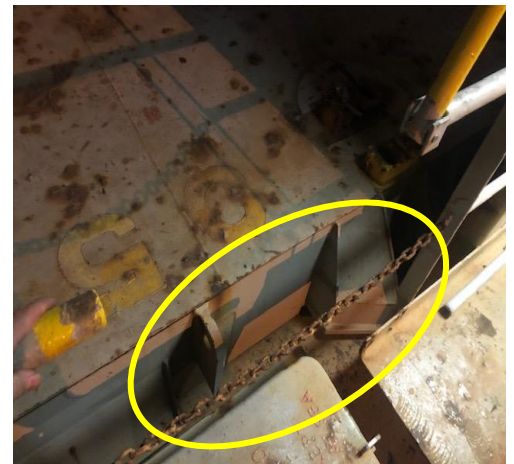
Incident Details: Hatch Foreman (HF) was working onboard the vessel and opened the bar of the access point that led from the stanchion walkway onto deck, at bay 09, in the 05 cell position. As he stepped across onto deck, he tripped over the Safety Chain that was located at shin height (15 – 18cm). He fell forward and landed on his elbow.

Direct causes: *The Safety Chain sits just above Hatch Lid height and is not clearly visible due to it being discoloured and its location. It is only located at below deck manhole lids at 2 locations throughout this vessel.*

- Safety Chain to be removed permanently, as to eliminate trip hazard
- Safety Chain to be painted by Shipping Line- Bright or florescent Paint the same as opening bars (Yellow)
