SAFETY ALERT

Ref No: SA-002-2023

Subject: Worker impacted by abnormal load during transit

THE BRISTOL PORT COMPANY	SAFETY ALERT	SY059 S&T Ref: Abnormal Load Date: 28.09.2022
Leadership	Ownership	Learning

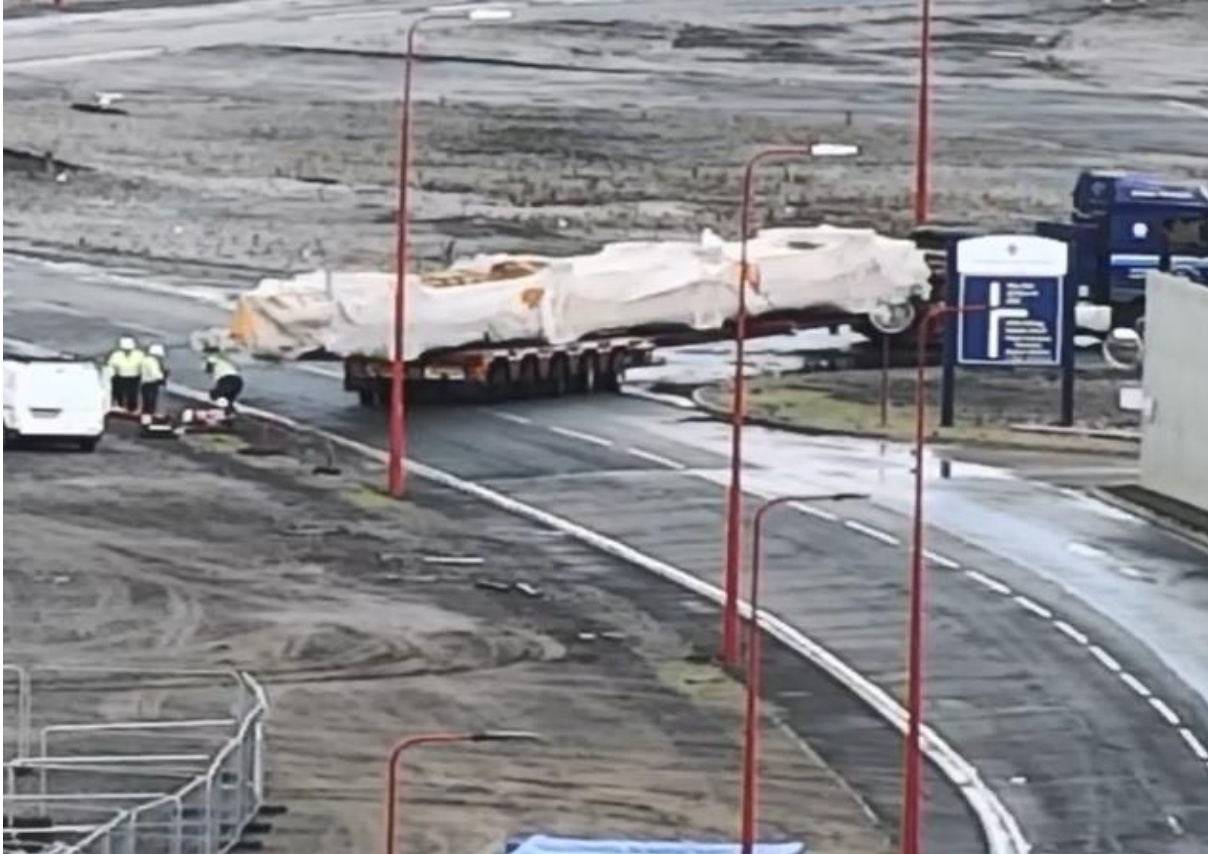
Operative struck by abnormal load.

At Avonmouth Dock Bristol, a lorry transporting project cargo to the loading vessel collided with an electrician who was working on a damaged roadside lamp post column. The electrician reported only minor injuries at the time and did not require medical assistance. The lorry driver and vehicle involved in the incident had previously knocked down the lamp post the electricians were working on and making safe.

1. Some project cargo parts being transported were overhanging the trailer and exceeded government guidance requirements. No escort was in place.
2. Haulage companies RAMS were for generic activities and were not site or task specific.
3. Pre activity route survey failed to identify location of the incident as a potential obstacle or risk.
4. Lack of situational awareness by electrician's and haulier
5. No immediate mitigating actions implemented following the first incident to prevent reoccurrence.

1. Stop the job and review all operating procedures prior to restarting operation.
2. Review contractor control process and management of contractors when onsite.
3. BPC to have greater visibility of contractors/ sub-contractors RAMS when working joint operations.
4. Electrical department to review isolation procedures, risk assessments, and safe systems of work for all activities, especially focusing on roadside activities.

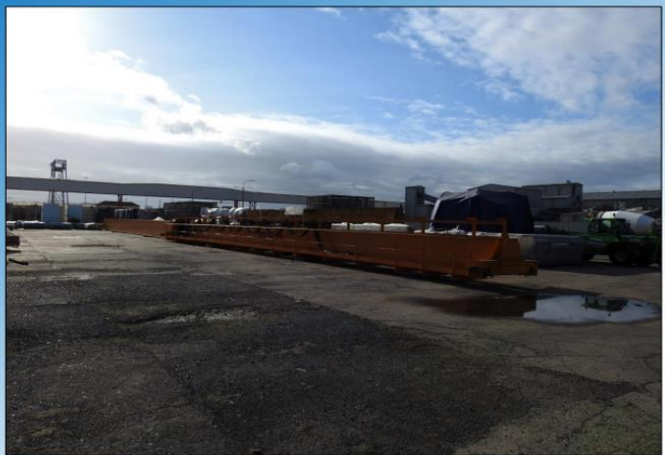
Task

- To move Gantry Crane Sections of approximately 28.3m in length.
- To be moved from a designated holding area to the Berth alongside S-Shed, within the confines of Avonmouth Port.
