SAFETY ALERT

Subject: Marine Casualty Investigation Board report Arklow Clan

**REPORT OF AN INVESTIGATION
INVOLVING THE MERCHANT VESSEL
“ARKLOW CLAN”
AT THE PORT OF ABERDEEN,
SCOTLAND
11 AUGUST 2021**

**REPORT NO. MCIB/315
(No.5 OF 2022)**

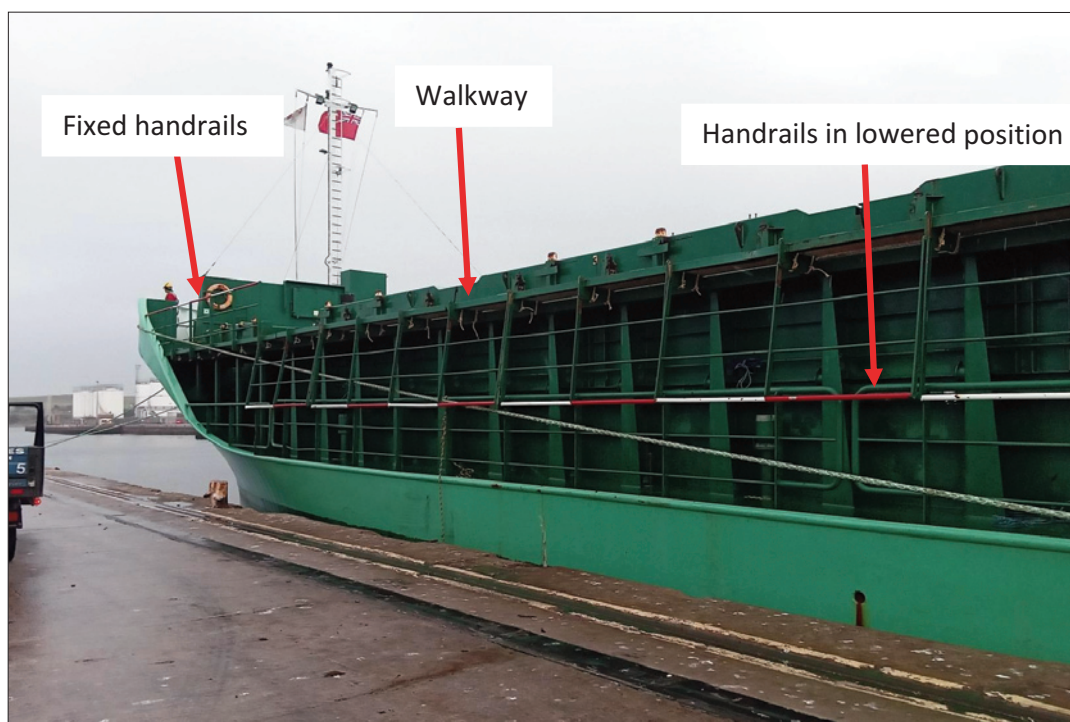
Photograph No. 1 - Taken by Vessel Crew on 11/08/2021 Post Incident

Two elevated grated walkways (catwalks) run parallel forward and aft on the port and starboard sides of the vessel. The walkways are located approximately 0.4 m below the top of the hatch covers in the closed position. They are accessed at the stern from the raised quarter deck and forward via the forecastle deck. Fall protection whilst using the walkway is provided by means of handrails, approximately 1.2 m in height. As the handrails extend above the hatch coamings, to facilitate certain cargo operations they must be lowered approximately 180° from the upright vertical position, to the downward ‘hanging’ position. The operation is not routine, and the handrails are only infrequently lowered for certain cargoes or port requirements.

See Appendix 7.2 - Photographs of the Handrails Lowered in the Down Position (photographs taken post incident).

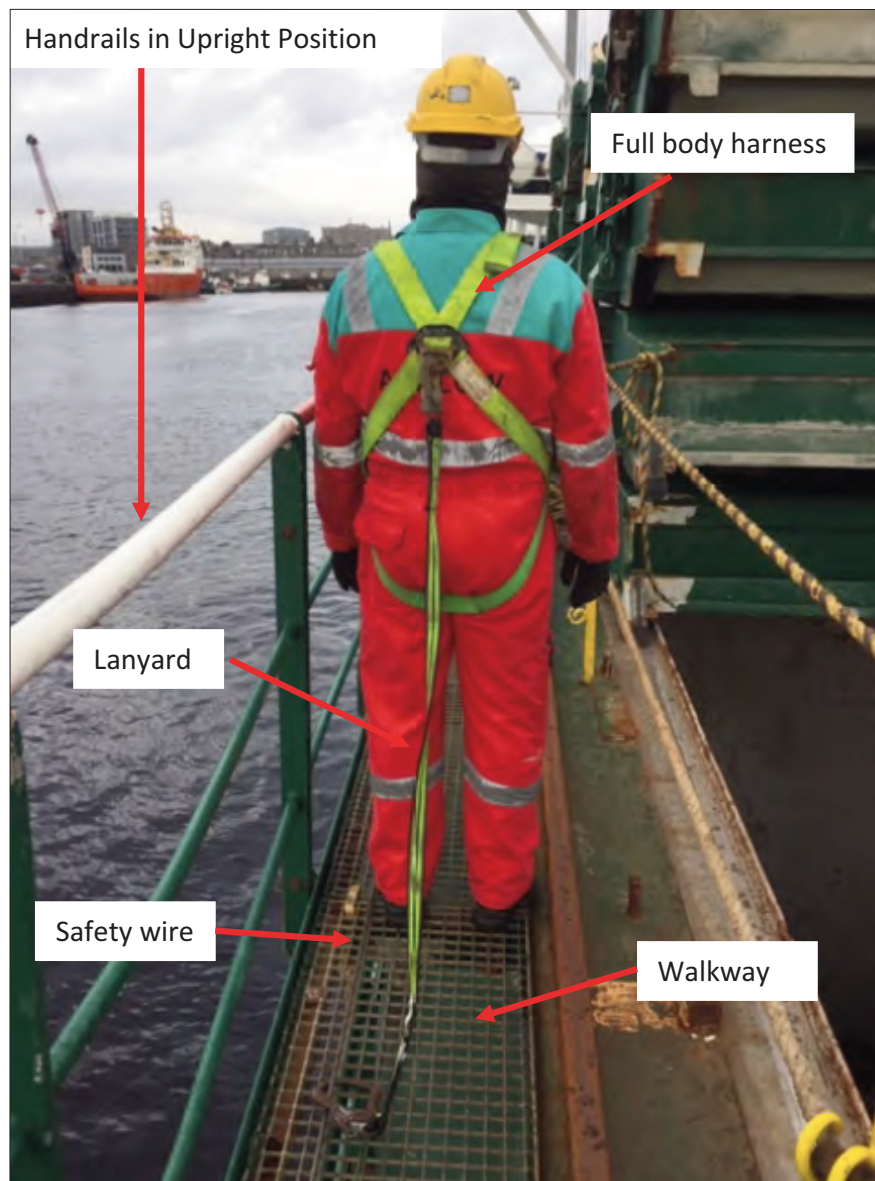
Photograph No. 1 - Crewmember Correctly Wearing PPE

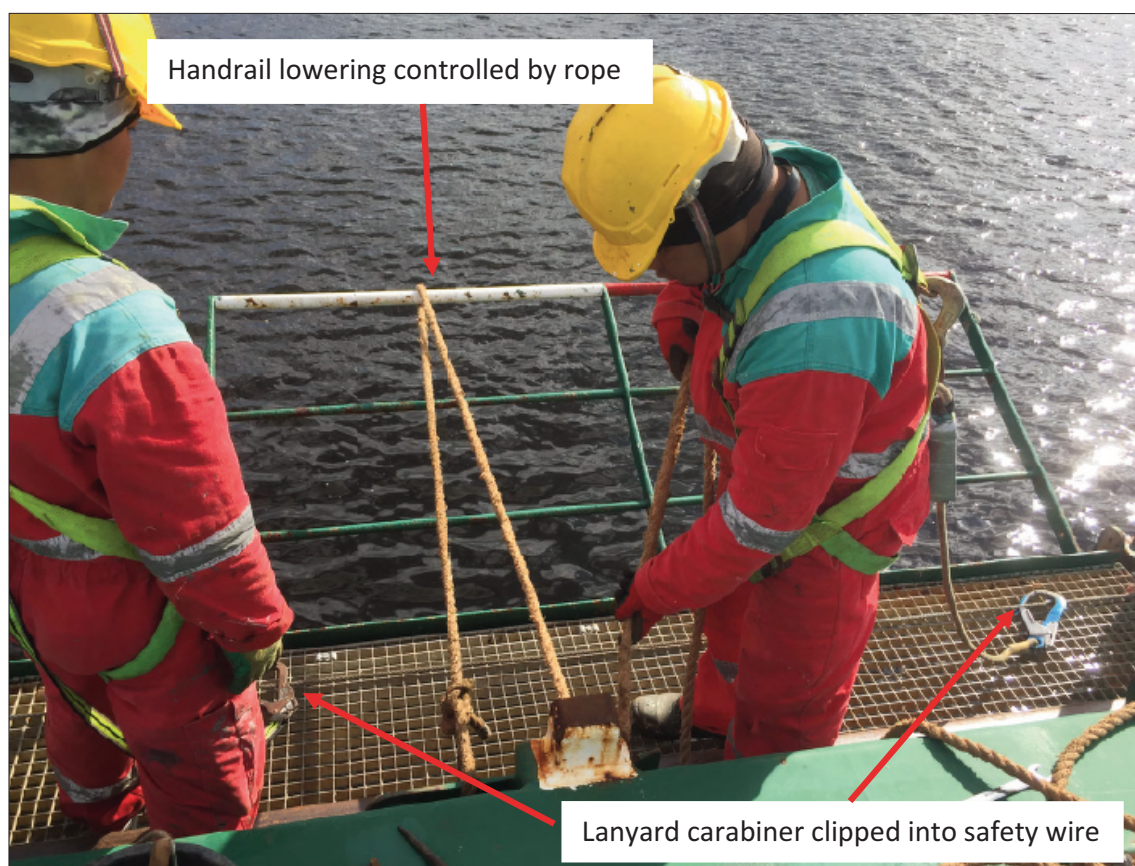
Photograph No. 2 - The Correct Method for Lowering Handrails

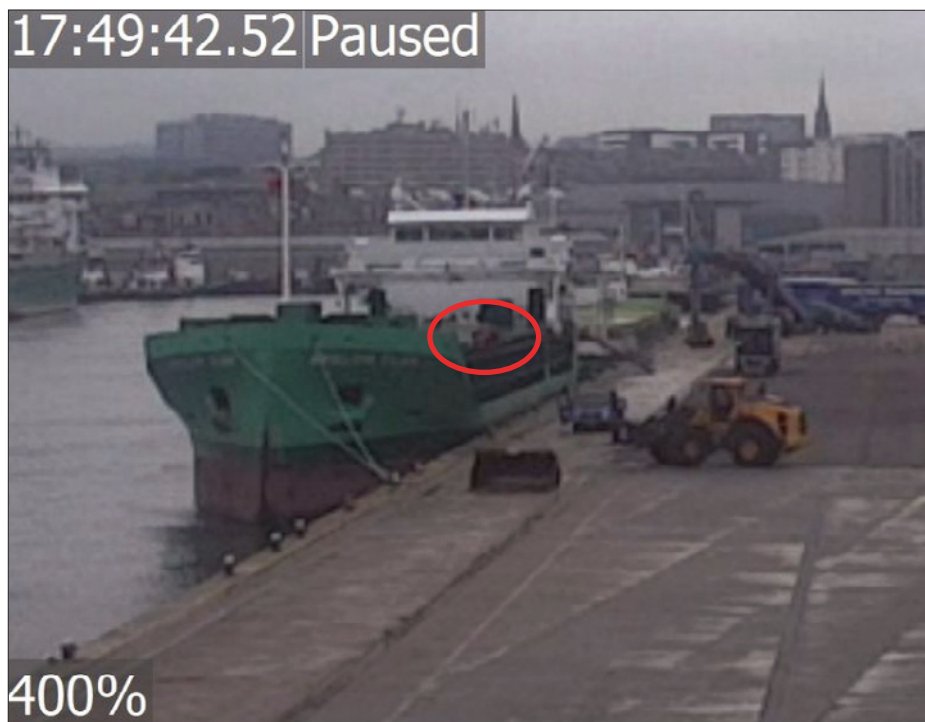
- 3.9 Almost immediately after completing mooring operations, starting at approximately 17.40 hrs working from aft and moving forward on the port side of the vessel, the Second Officer and AB 1 commenced removing the five nuts and bolts for each handrail section, each working on alternate bolts. AB 2 followed behind lowering the handrails with a rope. The witness accounts differ as to the exact sequence of events which followed. At around 17.49 hrs the Second Officer recalled standing up from the crouched position and losing his footing, in a bid to steady himself he grabbed the nearest handrail, but as the nuts and bolts had been removed the handrail gave way, causing him to fall overboard. AB 1 and AB 2 recalled observing the Second Officer leaning against a loosened handrail, before losing his balance and falling overboard.

Photograph No. 1 - Crew Working on Deck Pre-fall

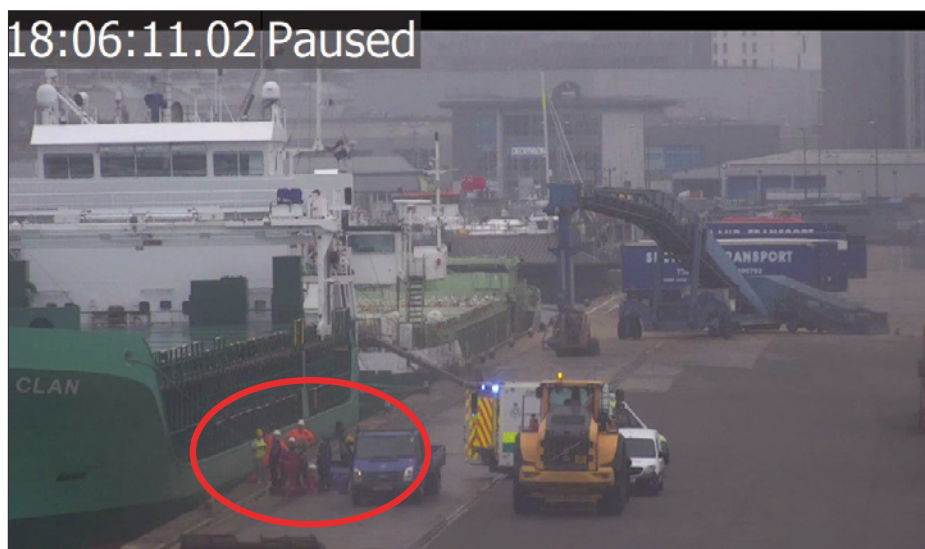
- 3.10 The net result was the same, at 17.49 hrs the Second Officer found himself falling towards the tarmacked quay below, a height of approximately 3.6 m. In a split second, he made the decision to rotate his torso and take the impact with his legs extended.

Photograph No. 2 - Second Officer Receiving Medical Attention on the Quay on Post-fall

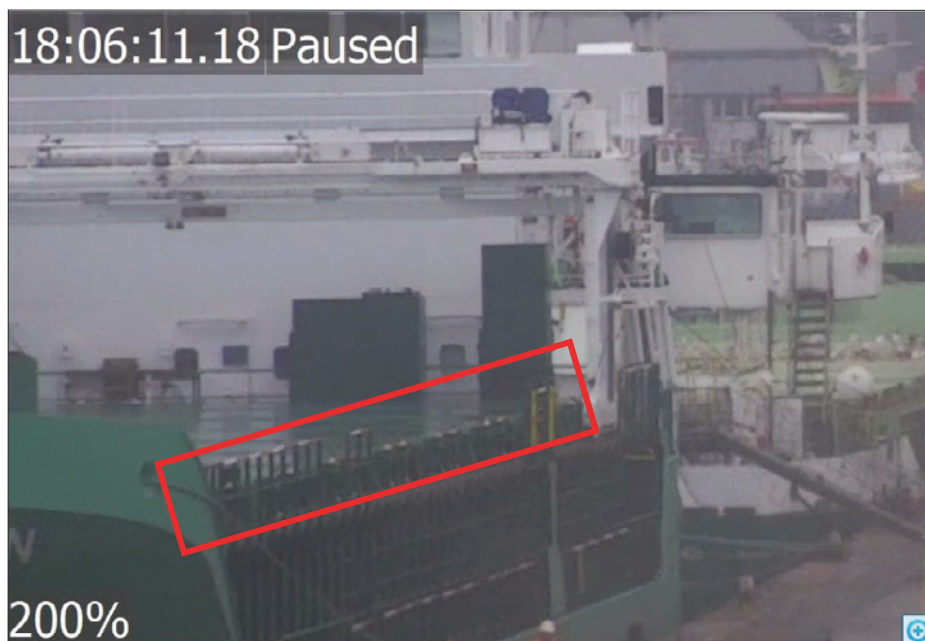
Photograph No. 3 - Position of Railings Post-fall. Partially in Down Position

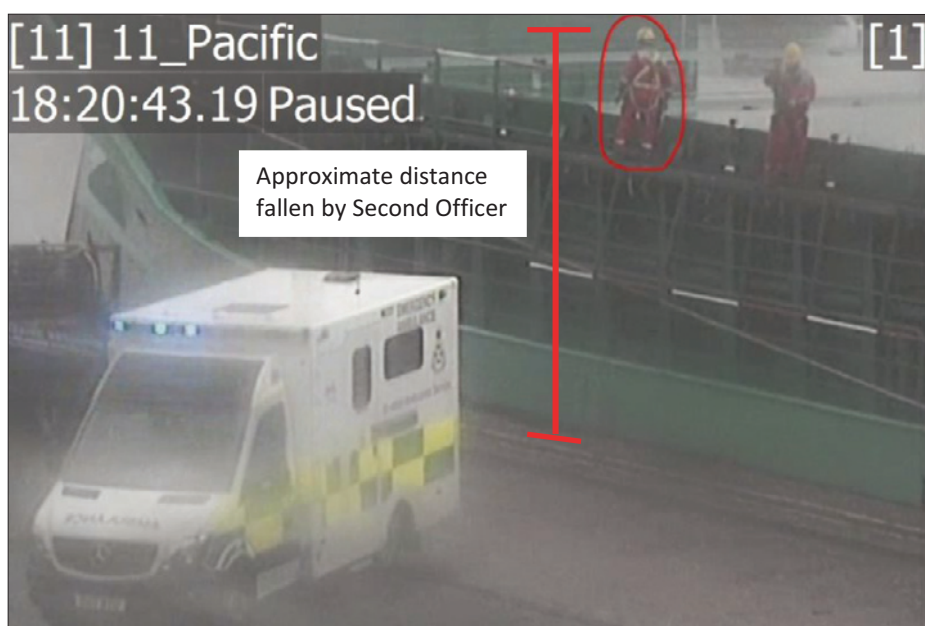
- 3.12 After stabilising the Second Officer's injuries, at 18.54 hrs the ambulance departed the scene. Two crew recommenced lowering the handrails, but they now wore the full body harnesses. During the lowering operation, at times they unclipped their lanyards to move, not fully utilising the safety wire and therefore limiting the effectiveness of the fall arrest protection, notwithstanding that crew had received onboard training in the use of harnesses when joining the vessel.

Photograph No. 4 - Crew Resume Lowering Handrails Post-fall
