Fire aboard Roll-on/Roll-off Vehicle Carrier *Höegh Xiamen*

Pier 20, Blount Island

June 4, 2020

Abstract:

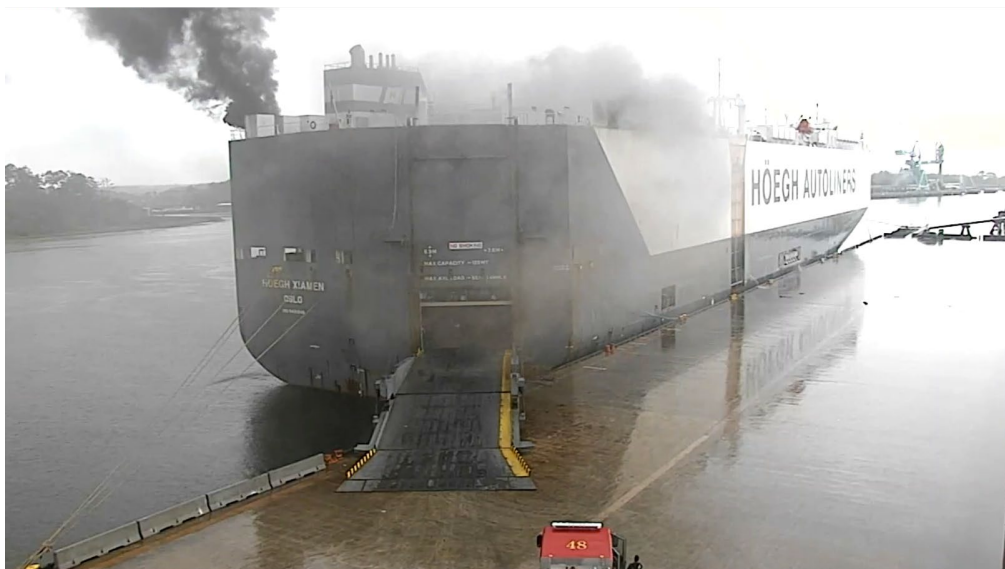
Figure 4. Smoke coming from aft cargo deck ventilation housing exhausts about 1603.
