# Navigating Safety within Ports and Harbours

## Fall from vertical quayside ladder has near-fatal consequences

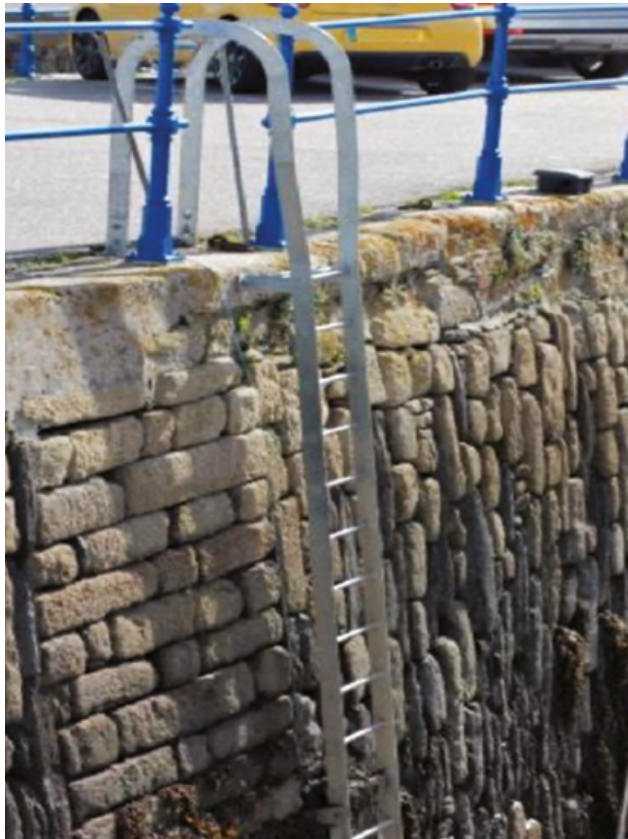
M1877

A fisher returned to their vessel with a guest in the late evening after they had met ashore. Both had drunk alcohol. It was low tide, and the vessel was approximately 6m below the quay edge due to the tidal range in that port.

As they climbed down the vertical quayside ladder, the guest fell off the ladder and hit the vessel's hull before falling, injured, into the water. The sea temperature was approximately 10° C (50° F).

Due to the range of the tide the vessel did not put out a gangway and instead relied on the vertical metal ladder

secured to the quay wall. At low tide this generated a significant risk of falling from height and onto the steel deck of the vessel and/or into cold water.

**Design (latent factor)** – Vertical ladders are exposed to the elements and prone to damage by vessels berthed alongside. There is no fall protection inherent within the design and unless regularly maintained they are prone to rusting and marine growth

The Master is responsible for ensuring a safe means of access to their vessel. This can be difficult, especially for small vessels that lack the space on board to carry or rig a gangway, or where the tidal range would make the gangway too steep to safely use. In these cases, Masters consider that they have no option but to use the vertical ladders as the only means of access or request a more suitable berth. By contrast, many port authorities view the vertical quayside ladders as 'self-rescue' equipment for anyone who falls into the water. They do not consider them as a safe means of access onto vessels, especially those that lie some distance below the quay edge at low tide. The rules that determine whether it is the port authority or the master that is responsible for providing safe access onto vessels vary by country and are not always clear. CHIRP urges regulators in those jurisdictions to reduce the scope for different interpretations wherever possible.

The need to recover casualties from vessels at low tide is reasonably foreseeable, so ports are strongly encouraged to conduct thorough risk assessments to deal with this scenario and develop an emergency recovery plan. This might require the purchase of specialist equipment or the nomination of a suitable 'casualty recovery' berth.
