# Entrapment by hatch cranes

Extended investigation after  
fatal entrapment on cargo ship

*The Hague, July 2022*

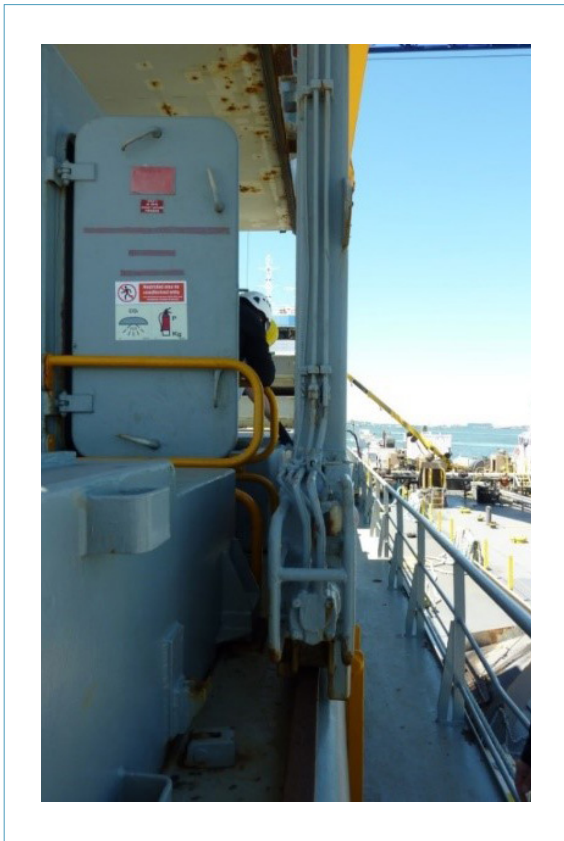
When the unloading of the cargo from hold no. 1 was almost completed, three crew members received the order to close the hatches of the hold. The crew member charged with operating the hatch crane walked to the hatch crane and clambered up to the location of the controls. The other two crew members would assist the operator from the gangway. After switching on the hatch crane, the operator asked via transceiver if the operating range of the crane was free from obstacles. This was confirmed by the other two crew members, one of which the later victim. Subsequently, the operator moved the crane in the direction of the bow and during this movement the victim got entrapped amidships. Immediately after the accident the operator was made aware of the mishap by local stevedores and a fisherman. The victim was on the port side, completely hidden from view to the operator on the starboard side.

Figure 3: Hatch crane near the hold entrance on port side.

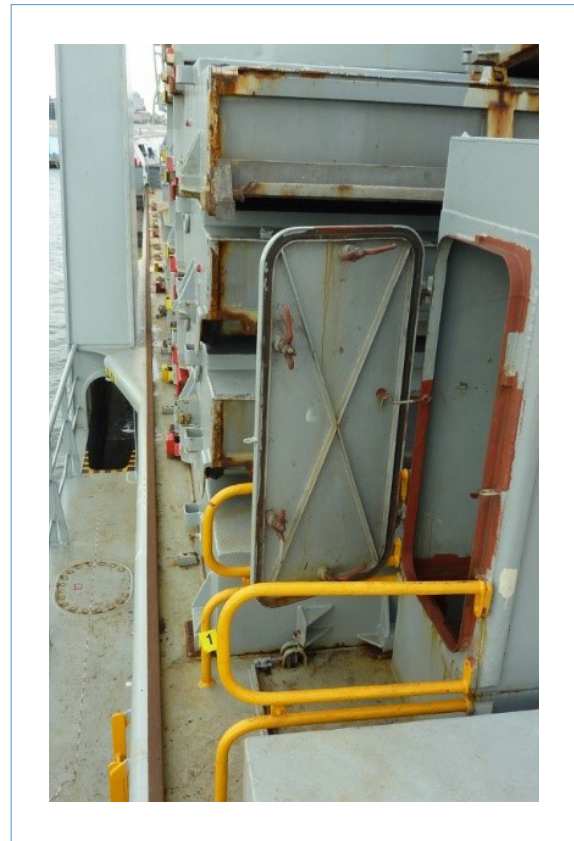
Figure 4: Hold entrance on port side, showing the watertight door and the stacked hatches.

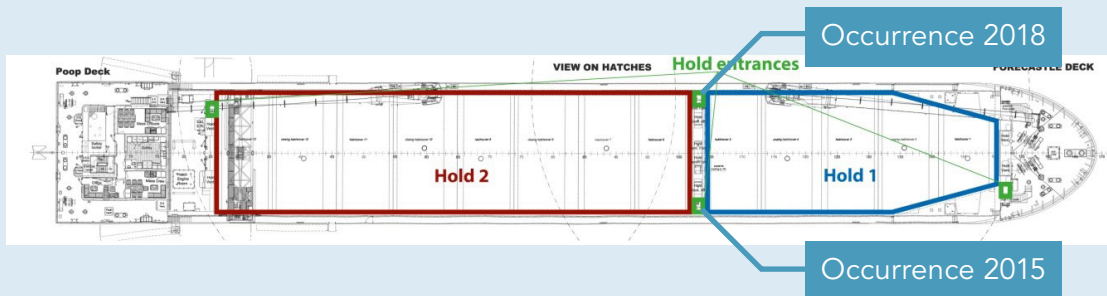
The occurrence on board of the Beauforce in 2018 was the second fatal entrapment in three years. In both cases, the victim was outside the visual field of the operator. Just like the first case, in 2018 the victim got entrapped between the moving hatch crane and fixed elements of the ship after emerging from a hold entrance amidships. In both cases, none of the crew saw what happened, but in 2018 local stevedores and a fisherman saw the occurrence taking place.

Figure 5: Ship's layout showing the location of both occurrences.

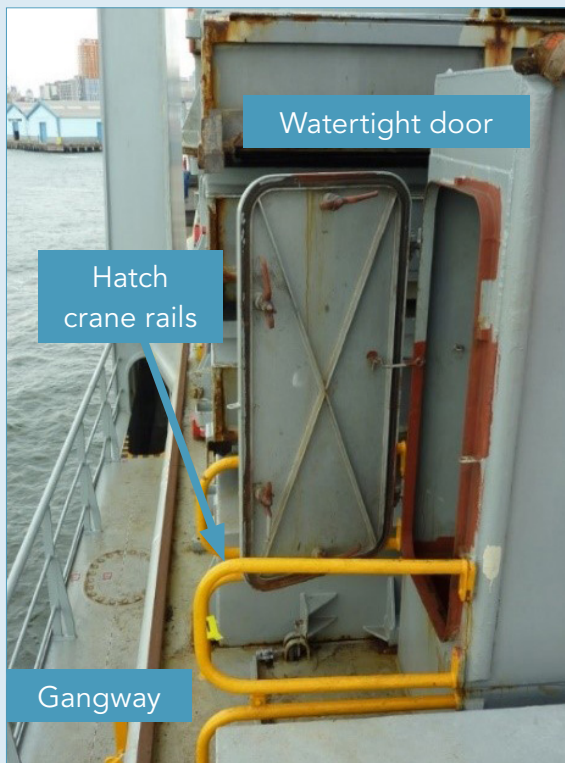
Figure 6: Access to hold number 1 on port side; location of occurrence 2018.

The fatal occurrences on the Beauforce happened in almost identical locations, namely the hold entrance amidships, the only difference being that in 2015 the occurrence was on the starboard side and in 2018 on the port side. On the Beauforce the hold entrance is amidships with a small portal at the top and a threshold (see figure 6). The threshold is 60 cm high and is intended to keep a safe freeboard. Within the portal there is a small landing at the top of a ladder giving access to a shaft of some 8 metres deep. This shaft provides access to the hold.

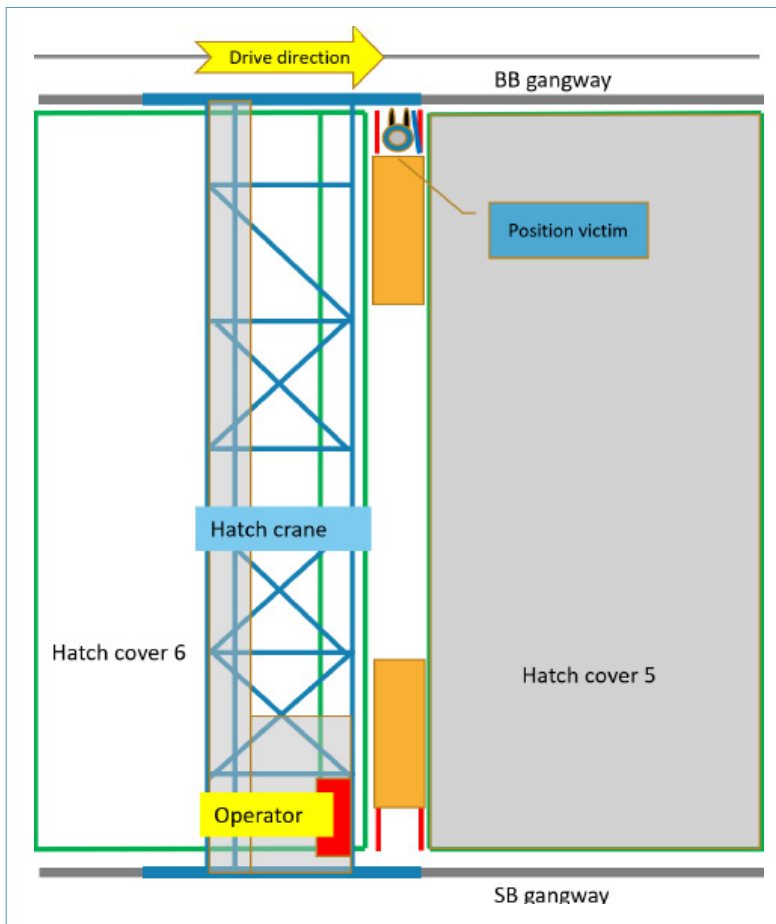
The investigation into the first fatal entrapment on board the Beauforce in 2015 showed that the view of the operator of the hatch crane was severely restricted. The position of the operator and the restricted view were the same in 2018 and therefore the operator could not see whether or not the victim had accessed the gangway. Considering the accident of 2018, the situation described above rendered the first control measure of the procedure infeasible. From his position the operator of the hatch crane could not see if there was anyone present in the port side gangway. People emerging from the hold entrance amidships were not visible to him. This is because the crane controls are on the starboard side. Furthermore, the construction of the hatch crane itself obstructs the view of the area immediately below the hatch crane.

This makes that the operator himself cannot see if the path of the hatch crane is clear. For this he largely depends on the input of others. The restricted view for the operator of a hatch crane is also mentioned in the ILT interim report on hatch crane<sup>5</sup>.

Figure 7: Top view with position of victim in 2018.

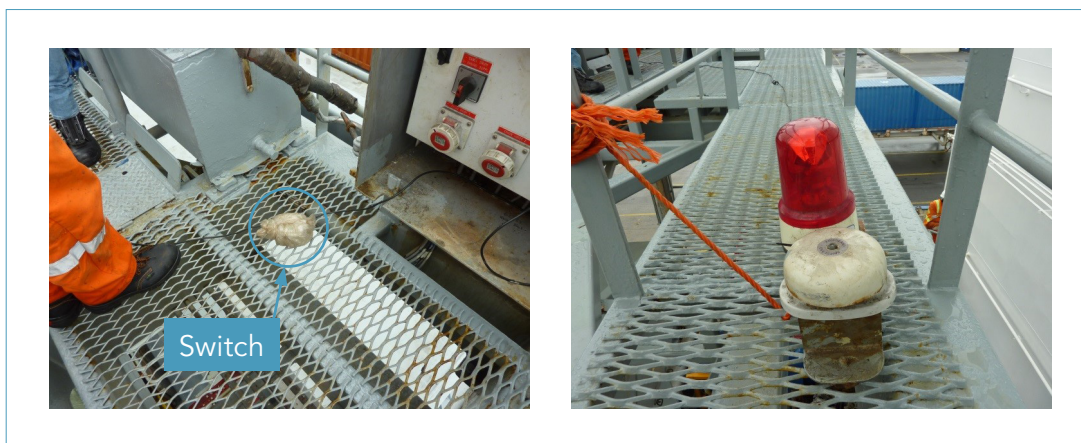
At the time of the occurrence in 2018 the original alarm bell was defective. Since there were no spare parts on board, the bell could not be repaired immediately. For this reason an alternative alarm system was in operation. This alternative alarm system required manual operation. The operating switch of the alternative alarm system was located next to the controls of the hatch crane. This system also caused the alarm to sound louder near the operator, causing other sounds to be drowned out and less audible for the operator. In addition, the bell was further away from the locations where the risk of collision with the hatch crane was present, such as the gangway and the hold entrance amidships. In some instances the alarm was not switched on. The statements made by the witnesses as to whether or not the alarm was sounding at the moment of the occurrence are ambiguous.

Alternative alarm system with on the left (figure 8) the switch and on the right (figure 9) the alarm bell and the strobe light.

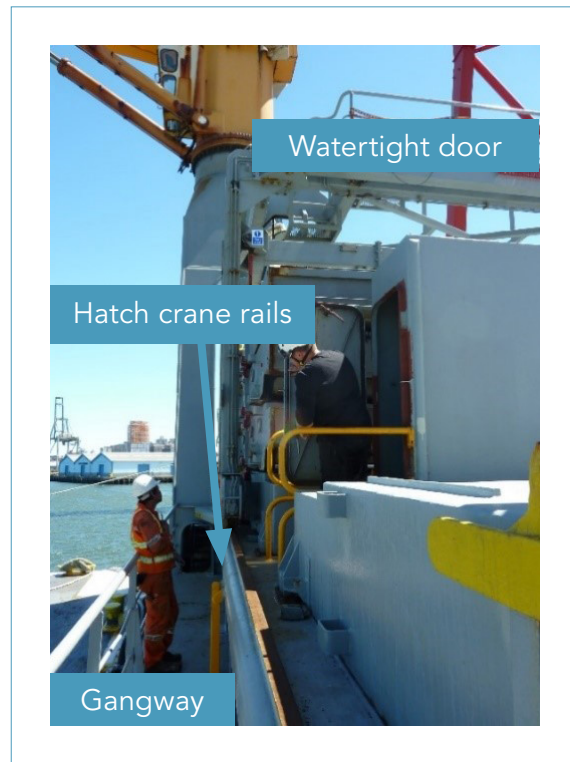
When someone wants to use the hold entrance amidships, the rail of the hatch crane needs to be crossed when accessing or leaving the gangway. This means that everyone using this entrance will be in the path of the hatch crane. This design therefore increases the risk of entrapment. The door of the portal is facing the crane track. There is a small distance between the portal and the crane track. Figure 10 shows the situation on the port side of the Beauforce.

The hold entrance amidships creates a walking route that crosses the path of the hatch crane. The door opening in the direction of the crane path and the short distance between the door and the gantry increase the risk.

Figure 10: This photograph shows that anyone stepping from the hold entrance amidships is very near to the path of the hatch crane.

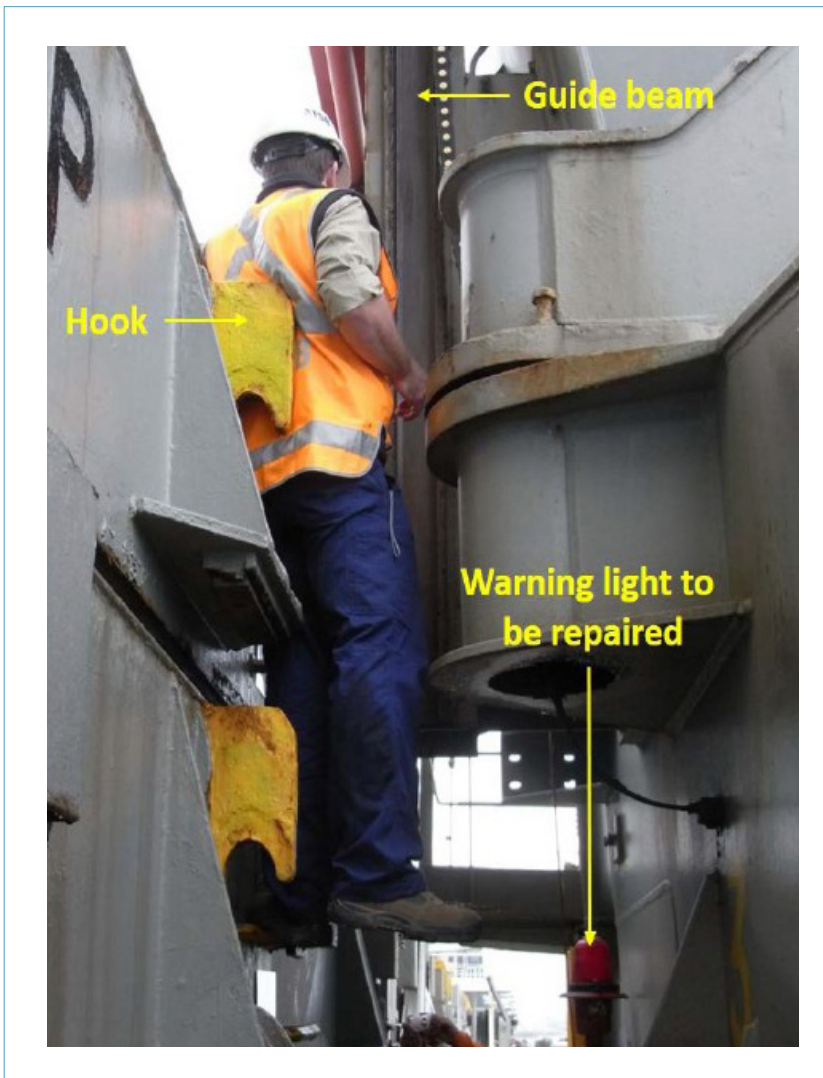
Nobody saw what happened, and therefore investigation by the Australian Transport Safety Bureau (ATSB) was not conclusive as to the actions of the crew member at the time of the occurrence. Tools and a new warning light were found close to the accident location. Partly on the basis of this finding, the ATSB concluded that the victim probably had the intention of replacing the defective warning light of the hatch crane and that he had climbed up two hatches in order to do so. On the basis of forensic evidence it is assumed that he became entrapped between the stacked hatches and the moving hatch crane.

The ATSB states that prior to the assumed actions of the victim there had not been any communication in relation to his intention of repairing the warning light. The acoustic alarm was serviceable but could not be heard from the victim's location. As the warning light was defective, he probably did not notice the hatch crane moving his way. Figure 12 shows the assumed location of the victim during the entrapment.

Figure 12: Reconstruction of the occurrence; the victim was probably standing on a ladder of the stacked hatches. (Source: ATSB)

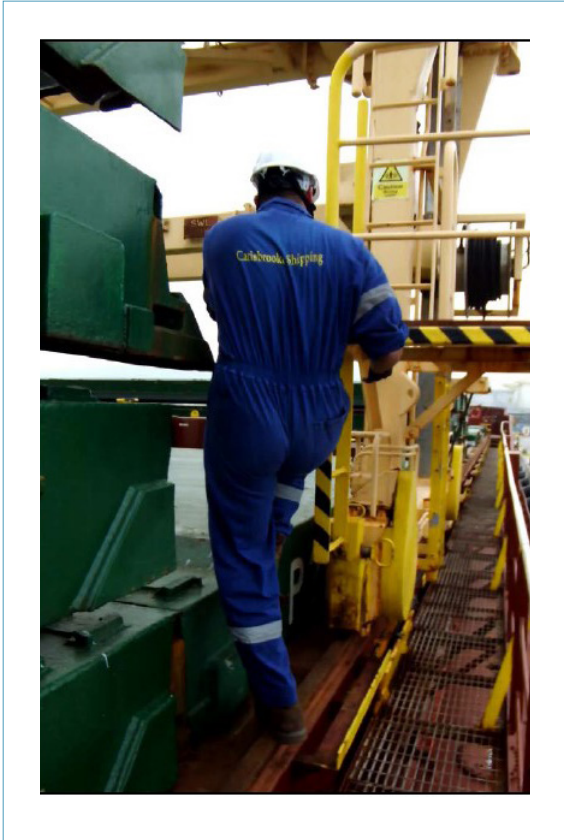
After it became clear that the vessel had to depart earlier, the later victim went on deck to sweep up cement dust. This took place simultaneously with hatch crane operations. Shortly before the occurrence, the operator stopped the hatch crane near a stack of hatches at the same time the later victim was also there. The later victim then climbed on the hatchway coaming in order to step between the hatch crane and the stack of hatches. The crane operator did not notice this. At the same time the victim moved between the hatch crane and the stack of hatches, the operator started moving the hatch crane which caused the victim to become entrapped (see figure 16 and 17 for the MAIB reconstruction). The victim died of his injuries.

Figure 16: Reconstruction of the victim climbing between the stack of hatches and the stationary hatch crane. (Source: MAIB)

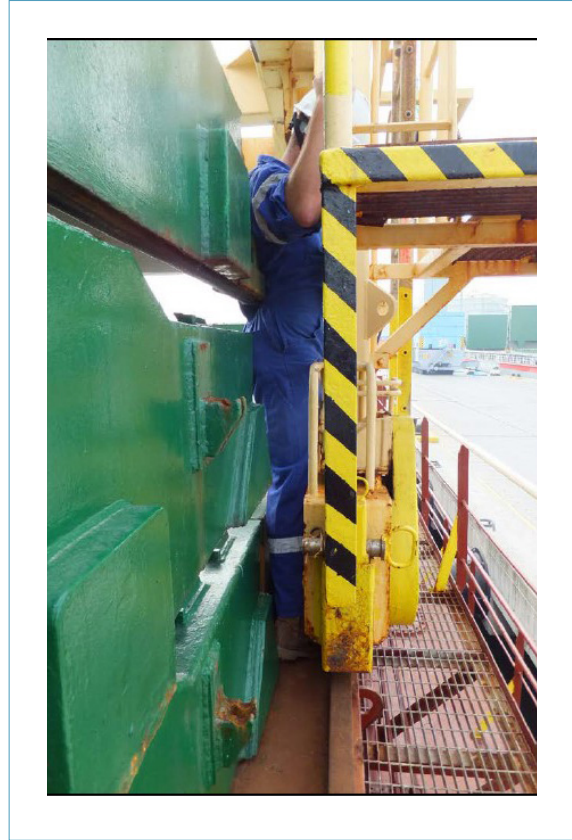
Figure 17: Reconstruction showing the space between the stacked hatches and the hatch crane. (Source: MAIB)

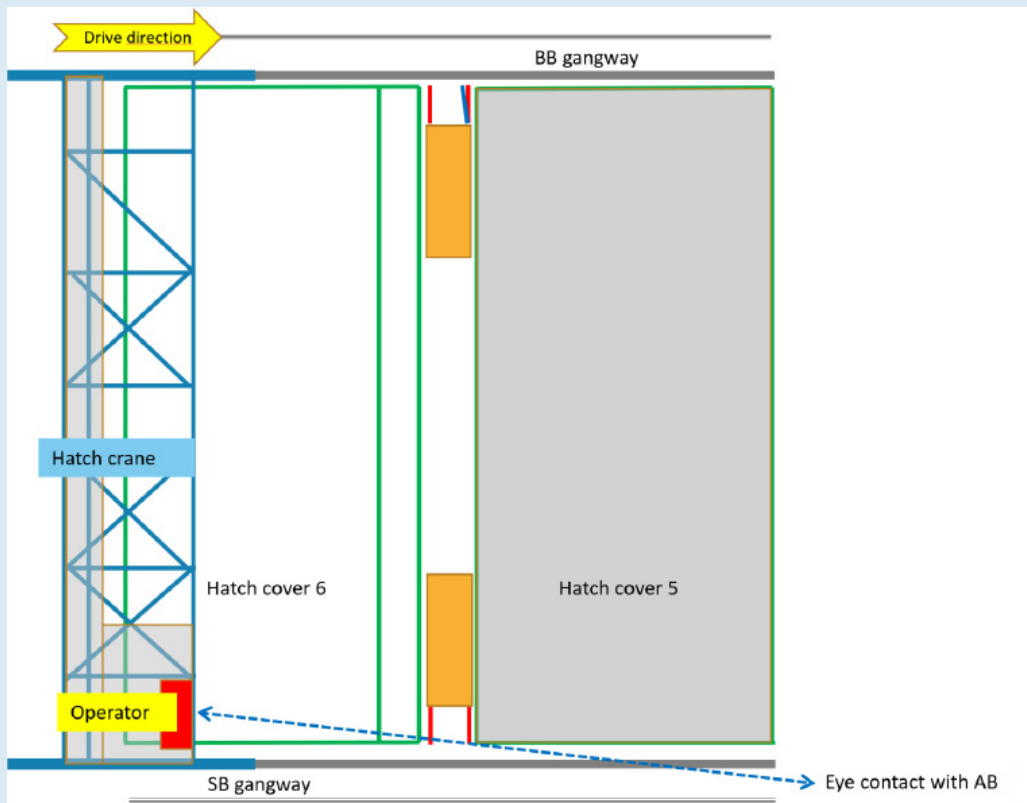
The construction of the hatch crane is such that the operator only has a restricted view of the starboard side, requiring assistance by a second person when operating the crane. The later victim asked if the third deckhand could assist him in closing the hold, with which the first officer agreed. The third deckhand was actually standing in the starboard gangway and had visual contact with the operator. The operator has practically no view of the port gangway and indicated that he could not see if the victim was there.

Figure 20: Top view direction of crane travel.
