SAFETY ALERT

Ref No: SA-005-2023

Subject: Collapse of trailer legs

LESSONS LEARNT: COLLAPSE OF TRAILER LEGS

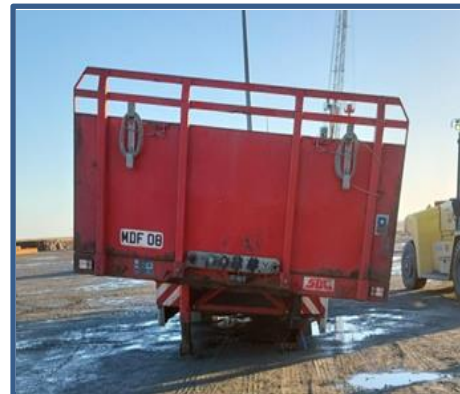
During a routine loading of a freestanding tri-axle trailer, the trailer collapsed on the nearside landing gear leg, after the third pack was loaded. The trailer was loaded from the offside.

The trailer was left with landing gear set too high or over extended causing the trailer to be unstable at the headboard end when loaded.

Image 1: Collapsed trailer

1. A safety alert was issued, highlighting the increased risk of trailer leg collapse when the legs have been over-extended prior to loading.
2. A Tool Box Talk (TBT) was held with the FLT operators to raise awareness of trailer leg heights and the potential for landing gear feet movements during loading.
3. The port investigated the possibility of using trestle's to support the trailer during loading but these were not suitable for this application.
4. A review was undertaken of the RA/SSoW's to capture incident experience, suitable mitigation and whether inclusion of banksman would reduce or increase overall task risk. It was decided that a banksman would not be a further suitable control in this loading activity as this would create a potential person/plant interface risk.
5. A trailer inspection checklist has now been created to inspect and monitor trailer before and during load out.

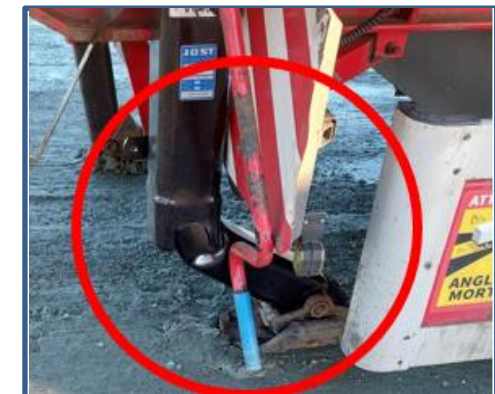
- The feet on the landing legs are JOST, S-Foot designed for working on type-1 aggregate, suitable for uneven ground, to lay flat when set and hold the load. They can move and shift position when loads are applied to trailer.
- It was noted after the leg failure that both legs had been over extended.
- When loading the trailer the weight can shift on the extended legs, which can move them forward changing centre of gravity.
- Ground surface was wet, type 1 aggregate, slightly uneven and subject to periodic levelling. The feet had dug into the ground when the load was applied, digging in on the leading edge.
- The FLT operators had not experienced a collapsed trailer or failed landing gear previously, so had not noticed the trailer legs shifting.

Image 2: Collapsed landing gear
