MIR-23-23

## Fire aboard Tank Vessel *S-Trust*

On November 13, 2022, about 1530 local time, a fire started on the bridge of the oil tanker *S-Trust* while the vessel was docked at the Genesis Port Allen Terminal in Baton Rouge, Louisiana.<sup>1</sup> Fire teams from the vessel's crew extinguished the fire about 1550. There were no injuries, and no pollution was reported. The damage to the vessel was estimated at \$3 million.

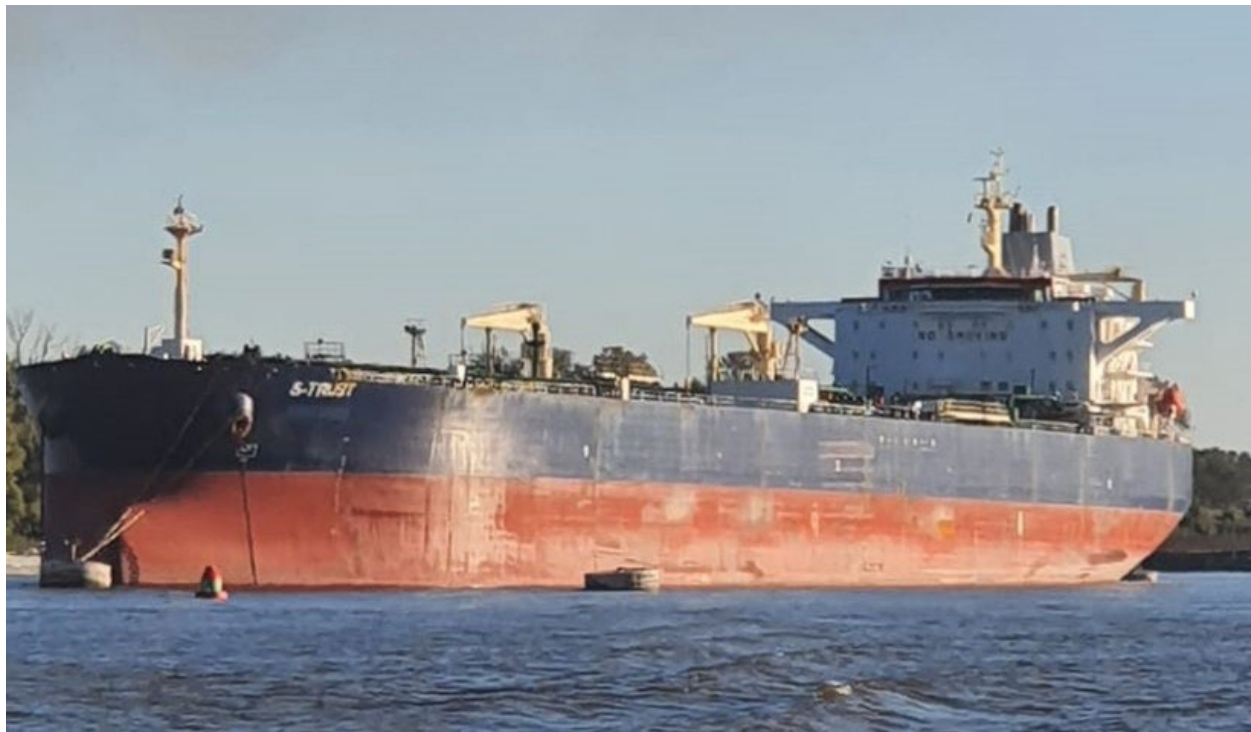
**Figure 1.** *S-Trust* at anchor following the casualty. (Source: US Coast Guard)

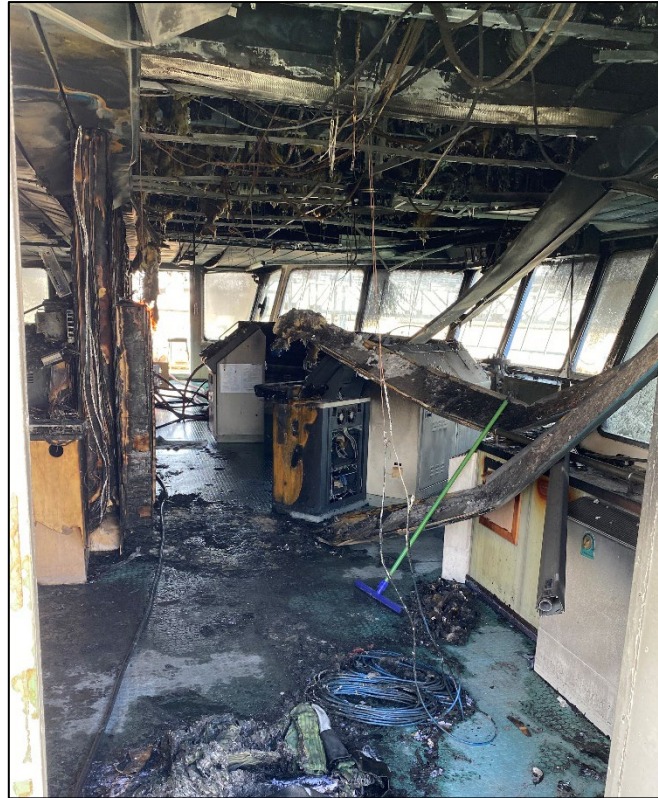
Investigators from the Coast Guard and the Bureau of Alcohol, Tobacco, Firearms and Explosives (ATF) discovered extensive damage throughout the bridge, including significant smoke and thermal damage. There was no damage noted to any of the lower decks in the superstructure. The navigation systems, communication systems, and alarm systems were damaged beyond repair.

**Figure 3.** The damage to the bridge. (Source: Coast Guard)

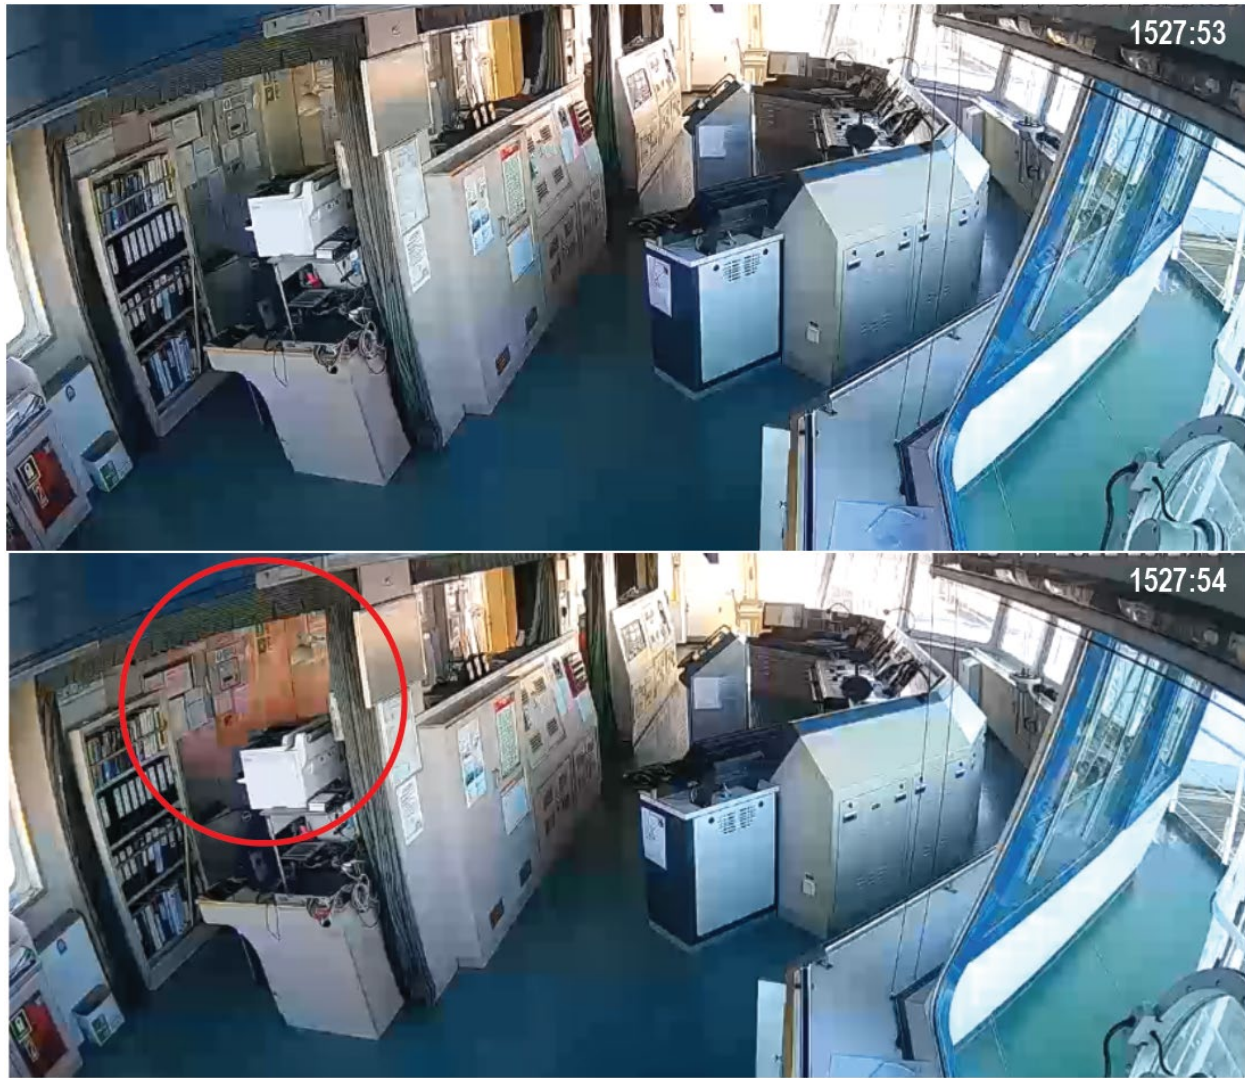
At 1527:54 local time, the footage showed an orange flash immediately followed by a puff of smoke by the communications table. Following the initial flash, the video showed smoke rising up and increasing in volume and thickness.

**Figure 4.** The bridge closed-circuit camera footage showing the bridge before the initial flash (top), and the flash and smoke, circled in red, at the communications table (bottom). (Background source: Stalwart Management Ltd)

The closed-circuit camera on the bridge captured an orange flash immediately followed by a puff of smoke in the area of the communications table where batteries and chargers for hand-held radios assigned to the bridge were located. Following the flash, smoke and flames were seen growing and expanding as combustible material was consumed by the fire. The ATF concluded that the fire was caused by one of the lithium-ion battery cells on the communications table exploding. The video and other evidence support the ATF findings.

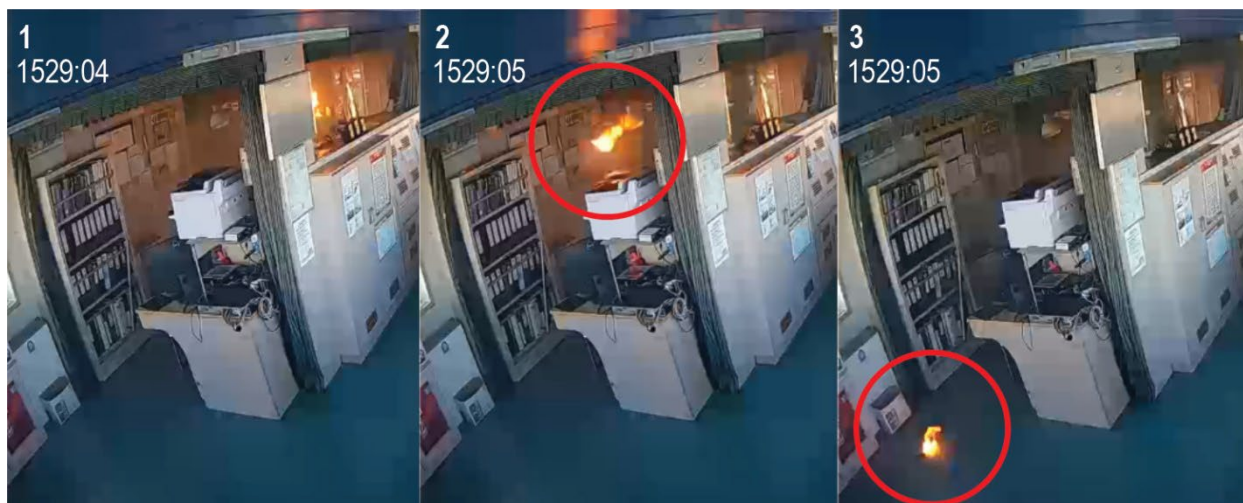
At 1529:04, the footage showed another orange flash in the same area as the first one, followed by an object on fire, which flew from the area of the flash to the starboard side of the bridge, where it landed on the deck in front of the lifejacket locker and continued to burn.

**Figure 5.** Photos from the bridge closed-circuit camera showing (1) a second explosion, (2) an object on fire propelled into the air (circled in red), and (3) the object, still on fire, landing on the floor (circled in red). (Background source: Stalwart Management Ltd)

video captured a second flash, followed by a flaming object being propelled from the fire and landing on the deck of the bridge, where it continued to burn. This was most likely the other missing lithium-ion cell from the same battery. Based on the video, investigators determined that the second missing lithium-ion cell also experienced a thermal runaway, most likely initiated from the heat of the fire started by the initial battery cell thermal runaway.

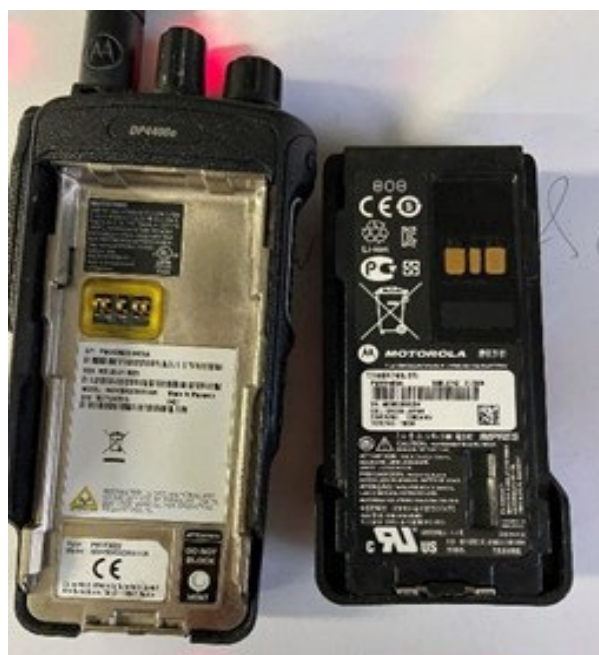
**Figure 6.** A Motorola DP4400e radio and lithium-ion battery used on the bridge of the *S-Trust*.

The two radios assigned to the bridge were a Motorola DP4400e radio, which used a lithium-ion battery, and a Motorola GP328 radio, which used a nickel-metal hydride battery. A crewmember informed investigators he believed that the batteries for those radios were not charging the day of the fire.

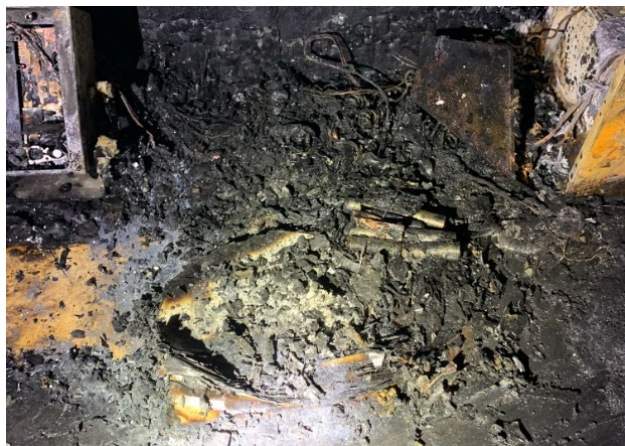
When investigators examined the area around the communications table on the bridge where the video showed the orange flash, smoke, and fire, they found the remains of a lithium-ion battery charger and a nickel-metal hydride battery charger. A closer examination found the remains of three batteries among the charger remains— one nickel-metal hydride battery (which contained six cells) and two lithium-ion batteries (which each contained two cells).

**Figure 7.** The remains of the lithium-ion and nickel-metal hydride battery chargers on the communications table. (Source: ATF)

The ATF origin and cause report for the fire stated that “the cause of this fire was determined to be an energetic event [explosion] involving a lithium ion battery located on the navigation [communication] desk.” The report detailed the examination of the other electronic devices, including a computer and a radio, on the communications table as well as all six electrical outlets that provided power to the desk. While all of the electronic devices and the outlets sustained fire damage, the ATF report ruled them out as potential sources of the fire. The ATF report also noted that there was a second explosion from within the ensuing fire on the communications table.

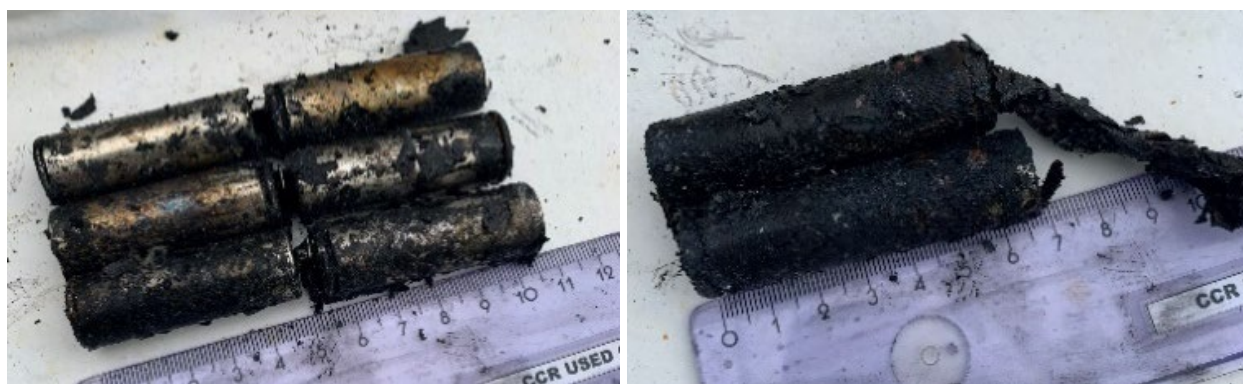
All six of the nickel-metal hydride battery cells were found among the charger remains and exhibited fire damage. Of the remains of the two lithium-ion batteries on the communications table, two cells from the same battery were found among the charger remains and had sustained fire damage. Although investigators found components of the second lithium-ion battery among the charger remains, its two cells were not found.

**Figure 8.** The nickel-metal hydride battery's cells (*left*) and remains of the lithium-ion battery cells and components (*right*) found on the communications table. (Source: ATF)

Investigators found the remains of three batteries (one nickel-metal hydride and two lithium-ion) on the communications table. The single nickel-metal hydride battery (all of its six cells) was intact; one of the lithium-ion batteries (both cells) was found intact in the remains of the chargers (one nickel-metal hydride charger and one lithium-ion charger). Investigators only found components of the second lithium-ion battery (a two-cell battery). Lithium-ion battery cell explosions are typically caused by a thermal runaway; as such, the initial orange flash and puff of smoke on the video feed was likely the result of one of the missing lithium-ion cells exploding due to a thermal runaway.
