SAFETY INVESTIGATION REPORT

REPORT NO.: 11/2023

MV EUROCATANIA

Serious injury to a crew member, during cargo operations in the port of Salerno, Italy

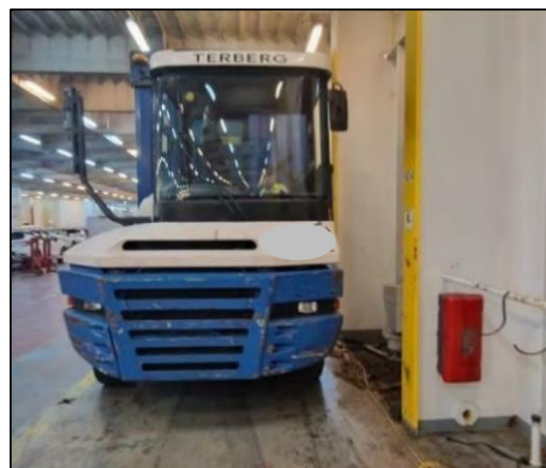
The first semi-trailer to be loaded came up the ramp from Deck 2, made a 180° turn on Deck 3, and lined up into the first lane to starboard, in reverse (**Figures 3 and 4**).

Figure 4: The tug master in line with the first lane on the starboard side (photograph taken after the accident)

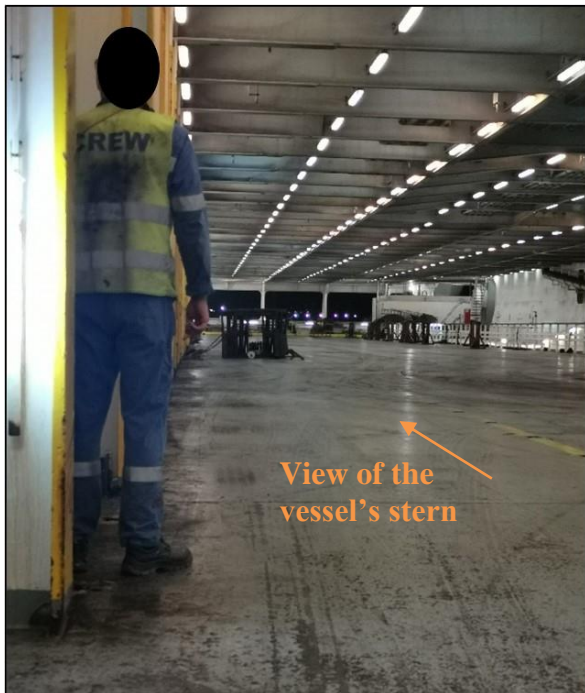
To reverse and manoeuvre the semi-trailer in position, the tug master driver's seat had been rotated by 180° to face the semi-trailer. During this time, the bosun was positioned to the port side of the semi-trailer, ready to push one of the trestles beneath the semi-trailer. The AB positioned himself towards the backend of the semi-trailer, close to the vessel's frames, to signal to the driver when to stop reversing (**Figure 5**).

Figure 5: Simulation showing the AB's position to direct the semi-trailer within the lanes

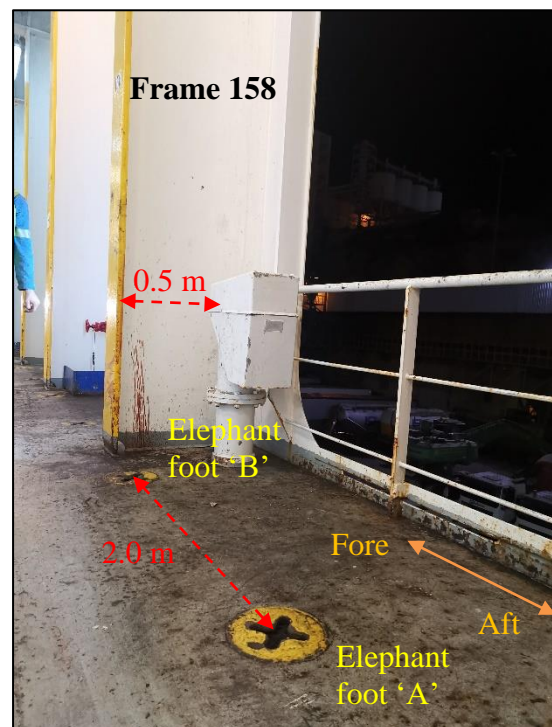
At the time of the accident, the AB was positioned near transverse frame 158. Two elephant foot lashing points were also in the area, to the starboard side of the lane (**Figure 6**). Elephant foot 'A' was about 2 m away from the face bar of transverse frame 158. A vent head was fitted close to the aft end of the frame.

Figure 6: Location of the accident

The AB was standing between transverse frames 154 and 158 while a semi-trailer was reversing in his direction. When the AB blew the whistle to signal that the semi-trailer was in position, it was highly likely that the tug master driver did not hear the signal. Consequently, he continued with his reversing manoeuvre. The AB was caught between the semi-trailer's side and transverse frame no. 158.

¹¹ The space between the semi-trailer and frame 158 was estimated as 0.3 m.

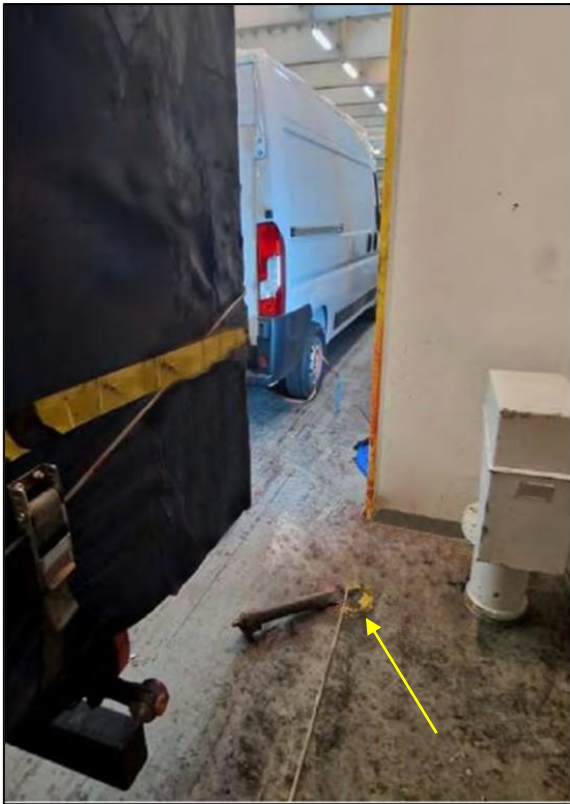
After the accident, it was noticed that one turn buckle had already been inserted into elephant foot 'B' (**Figure 7**).

Figure 7: The scene at Deck 3, after the semi-trailer was moved forward to release the AB (one turn buckle seen in position)

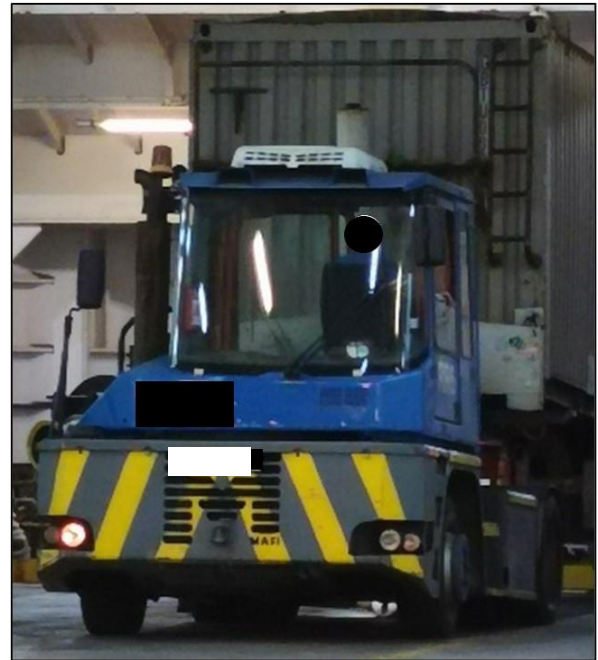
At the time of the occurrence, the driver was reversing and facing the semi-trailer (with his back to the windshield). This meant that he did not have a visual of the left-hand side mirrors fitted on the tug master⁷ (Figure 8) and he would need to lean his head out of the side window. The mirror on the right-hand side had a different attachment arrangement / design and was positioned further towards the rear end of the tug master⁸ and in such a way that with the seat rotated by 180°, the

Figure 8: A representative photograph showing how the position of the driver as he was reversing the tug master at the time of occurrence

⁷ Facing the semi-trailer with the driver's back to the windshield, the left-hand side mirror would be behind the driver.

In line with the discussion above, once the driver's seat was facing backwards, the driver would not have been able to see the AB's reflection in the left-hand side mirror, but he could see him physically if he had to lean out of the side window, enough to extend beyond the extreme width of the semi-trailer. Considering that the trailer was manoeuvring very close to the side shell, it may have not been possible for the driver to lean out his head far enough to see beyond the width of the trailer⁹.

Following this occurrence, the Company issued a circular across its fleet on the accident on board *Eurocargo Catania* and highlighted the need to keep adequate safe distance from the semi-trailers' rear end and to always have visual contact with the driver and utilise the tug master's rear-view mirrors.

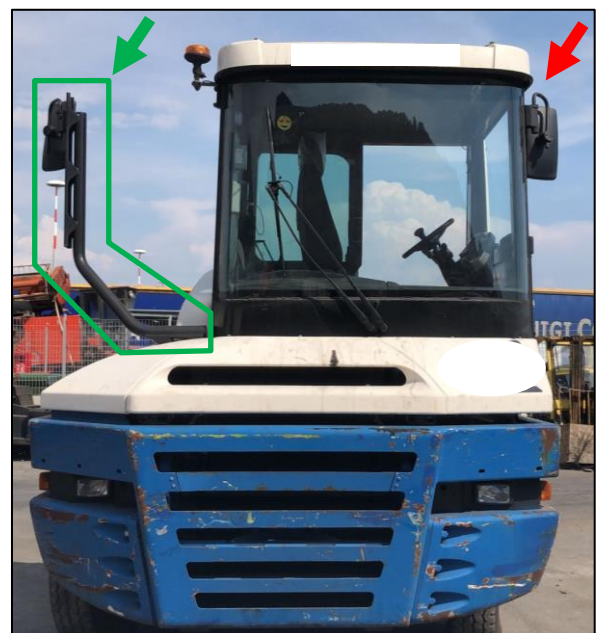
driver would still be able to see the reflection of the back end of the cargo unit in the side mirror (Figure 9).

Figure 9: The right-hand side mirror's attachment was designed differently from that on the left-hand side.

⁸ The right-hand side mirror was not in line with the left-hand side mirror.
