# SAFETY INVESTIGATION REPORT

REPORT NO.: 08/2023

## **MV OPALINE** **Injury to a crew member,** **during cleaning of cargo spaces** **in the port of Rotterdam, the Netherlands** **26 May 2022**

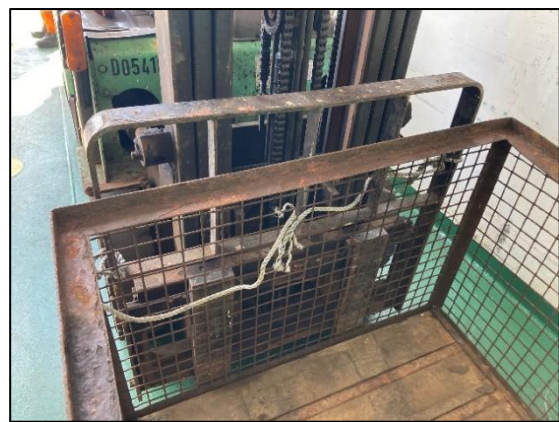
**Figure 1: A simulation of how the basket was tied to the FLT. In this photograph, the rope had already parted**

<sup>6</sup> The rope used to tie the basket to the forklift had been used as a heaving line in the past.

While doing so, the AB's centre of gravity shifted outboard of the basket, resulting in an unbalancing force acting on the basket, and which caused an additional strain on the rope securing the basket to the FLT. Consequently, the securing rope parted, the (unsecured) basket toppled over, and the AB fell from a height, sustaining serious injuries.

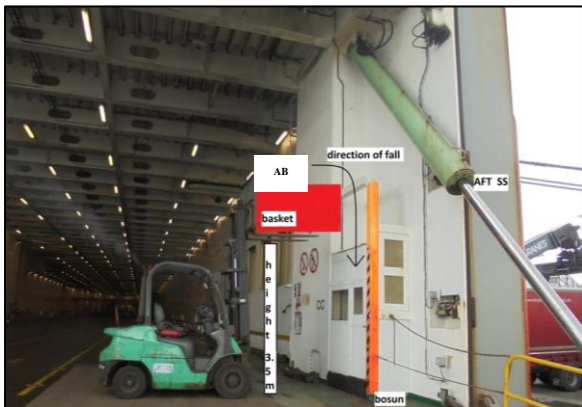
As soon as he shifted his position, the rope securing the basket to the FLT broke, and the basket toppled over with the AB. The AB and the basket fell from a height of about 3.5 m (**Figure 2**) to the deck, just missing the bosun.

**Figure 2: Simulation of the FLT set-up, indicating the height of the basket from the main deck**

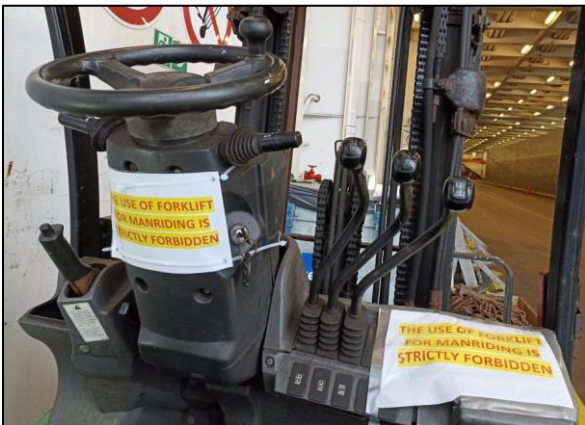
**Figure 3: Signs posted on the FLT on board *Opaline***

1. the chief officer's standing orders were amended to include the prohibition of man riding while operating the FLT;
2. signs to warn the FLT users were posted in the conning position of the FLT (**Figure 3**);
3. the Company issued a Fleetwide Notice to draw the attention of all the crew members on this accident, while reminding crew members of the previous similar occurrence on board *Ysaline*; and
4. a 'Forklift Familiarisation Checklist' was introduced in the SMM, prohibiting people from using the FLT to be lifted to higher areas of the vessel.
