LESSONS LEARNT: Extractor Flue Near Miss

Location: Medway – Sheerness – Warehouse 6

SAFETY BULLETIN

Ref No: SB-009-2023

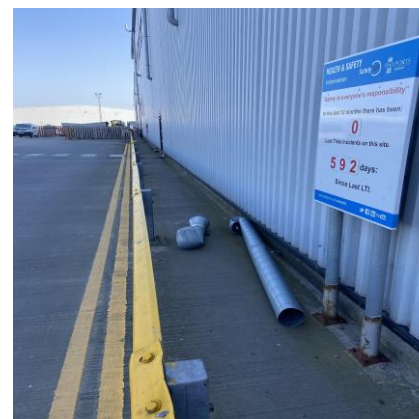
Image 1

During high winds, an aluminium Local Exhaust Ventilation (L.E.V) extractor flue broke its mounting from the side of a warehouse building, tore at a joint in the flue and fell into the pedestrian walkway below (See Image 1).

The dislodged flue pipe had initially extended above the eaves of the warehouse and was exposed to the prevailing wind.

The upper securing bracket detached from the cladding

Subsequently all flues have all been inspected and had further securing brackets installed and at the correct spacings as per the British Standard.

A local maintenance programme in addition to the thorough examination has been created to ensure the safety of the flues are maintained.

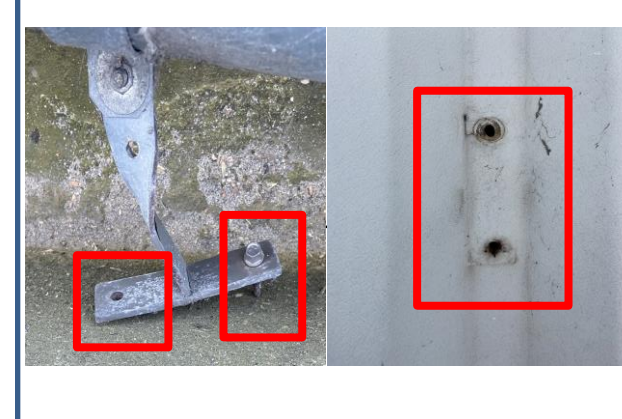
Image 2

- One of the sheet screws was missing from the bracket (See Image 2)
- Movement of the flue over time had elongated the fixing holes enough for the cladding screws to work loose
- The flue was not installed to the requirements of British Standard BS 5440, namely securing brackets were not spaced at intervals of no greater than 1.8m
- Gusting wind speeds on the day measured 32mph
