# LESSONS LEARNT: EMPTY CONTAINER DISLODGEMENT

**LOCATION:** CLYDEPORT – DUBLIN CONTAINERS & TRANSPORT LTD (DCATS)

# Safety Alert

Ref No: SA-004-2024

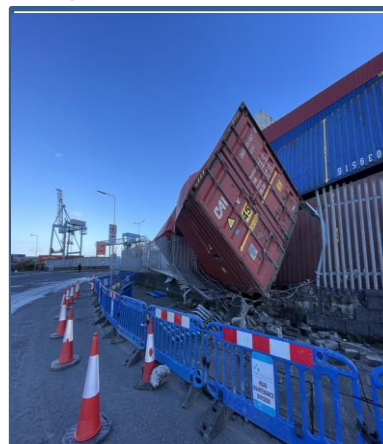
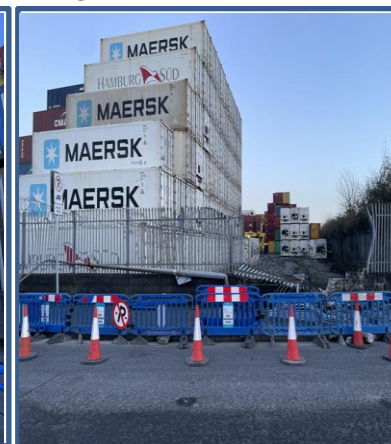
On the evening of Sunday the 21st of January 2024, Storm Isha passed through the Dublin area, bringing with it an Orange Weather Warning and extreme high-speed gusts of wind. At 18:57, an empty 45ft container stacked near the perimeter fence of DCATS was blown from its position, toppling down the tiers of the stack and landing partially on the fence below (See Image 1 and 2).

A second 45ft container followed, toppling down the stack – this landed on the container located on the fence, which due to its angle acted like a fulcrum, allowing the second container to clear the fence and come to rest on the public roadway outside of the Terminal. Afterwards, a further stack of containers toppled within the confines of the Terminal – Two of these containers cleared the internal fence and came to rest on the Terminal Exit Lane.

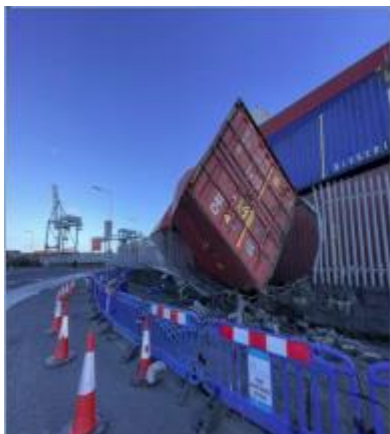
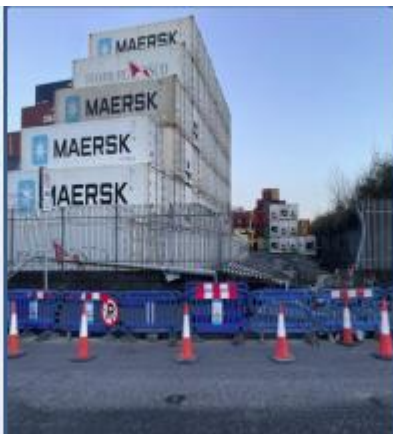
Image 1

The winds blew an empty 45ft container stacked near the perimeter fence from its position and it toppled down the tiers of the stack and landing partially on the fence. Following this, a second 45ft container toppled down the stack, over the first container and coming to rest on a public roadway outside the Terminal (image 1 and 2). A further stack of containers toppled within the Terminal – two of these cleared the internal fence and came to rest on the Terminal Exit.
