15 April 2024

# Safety Bulletin 4 /2024

## The right angle

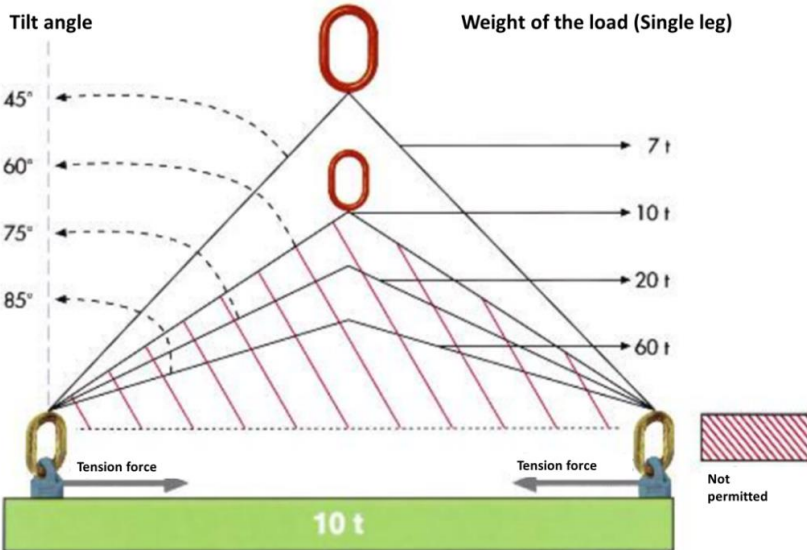
Sling load for a 10 t cargo unit. When the «tilt angle» is 75°, the load on each sling or «leg» is 20 t!

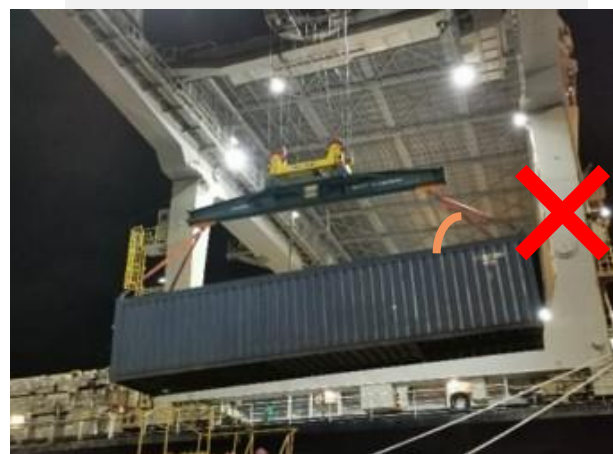
Regular ISO containers as shown below are designed for straight, 90° lifting angles only. The container lifting points may break at any moment, they are not designed to withstand horizontal forces.

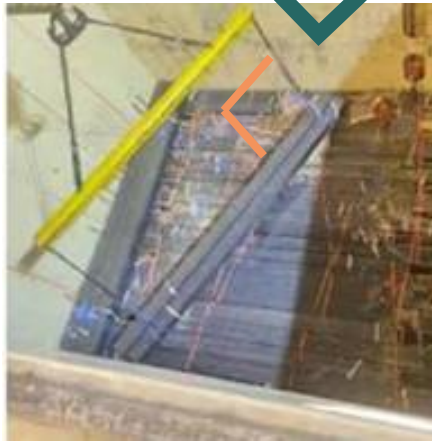
## Case 1

**LOADING:**  
Basket lift method (left) of steel bars. The lifting angles are 90° and safe.

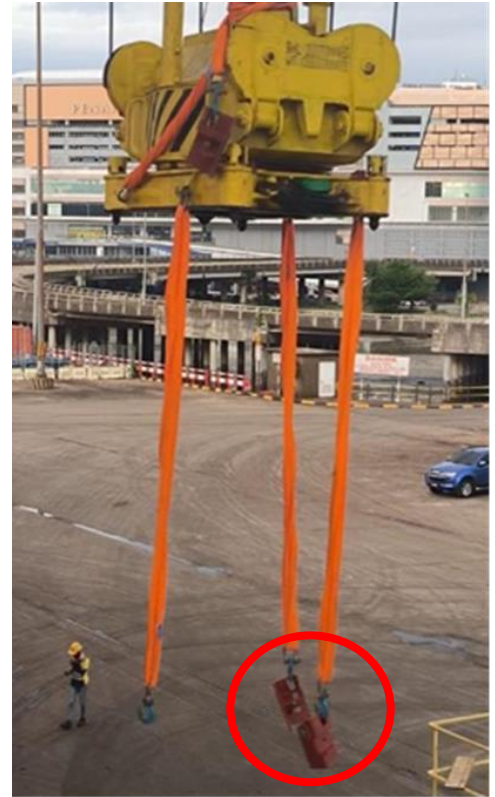
## Case 2

Lifting points in the corners of a box-shaped cargo unit were ripped off during a lift. The investigation revealed that the slings were too short, and the lifting angle was estimated to 78°. For regular lifting operations the angle shall not exceed 60°. As illustrated on the left, the horizontal forces increase tremendously beyond this limit. The forces exceeded the capacity of the lifting points.

Lifting points of the cargo units were ripped off. The slings were too short, and as result the lifting angles were unsafe.

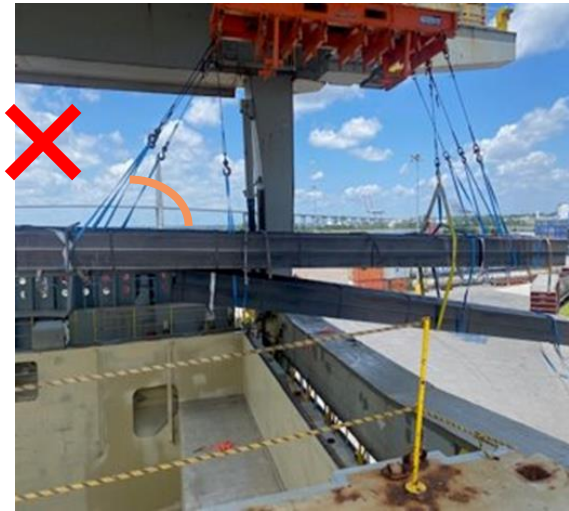
Steel bars were lifted using “basket” method. The slings started to slide and were cut by sharp metal bands keeping the metals bar together. The bars dropped and landed on the beam of the gantry crane.

**DISCHARGING:**  
The same steel bars, basket lift. Because of the angle, the slings started sliding and the cargo almost dropped down on the quay.
