# Two hook, or not two hook, that is the question

cargo vessel | accident to person

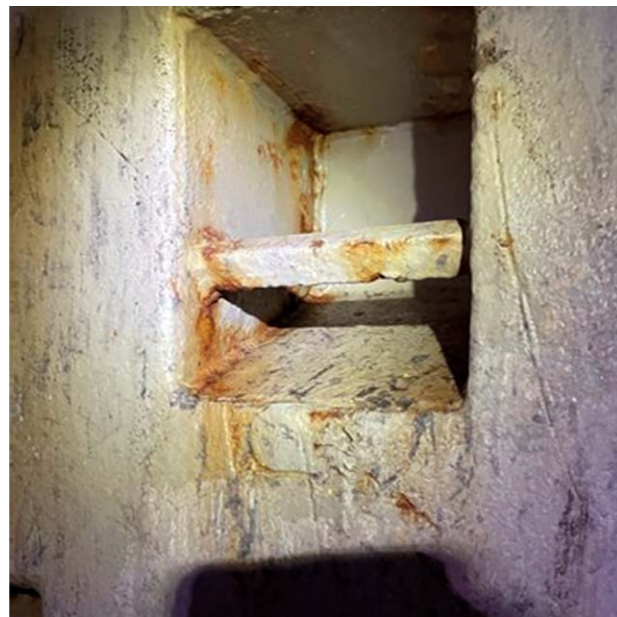
A couple of hours later, the ship's cook/AB was working at the bulkhead at the forward end of the hold. Wearing a safety harness with a lanyard and safety hook, the AB used the recessed footholds (Figure 1) in the side of the cargo hold to climb about 2.5m to access one of the bulkhead locking bolts and attached the safety hook.

The AB was unable to reach the locking bolt and, using one hand to hold on, disconnected the safety hook and attempted to move it to another position. The AB's foot slipped from the foothold and their hand slipped from the single handhold

Figure 1: A recessed foothold

- Equipment** → The safety harness worn in this case was equipped with only one lanyard and hook, limiting the ability of the wearer to move around safely at height. Once the safety hook is disconnected to move to another locking point, the wearer remains at height without any fall arrest or fall prevention measures apart from hand and footholds; this might be unsuitable in the local conditions. A harness with twin lanyards and safety hooks enables movement at height while providing a means of fall prevention.

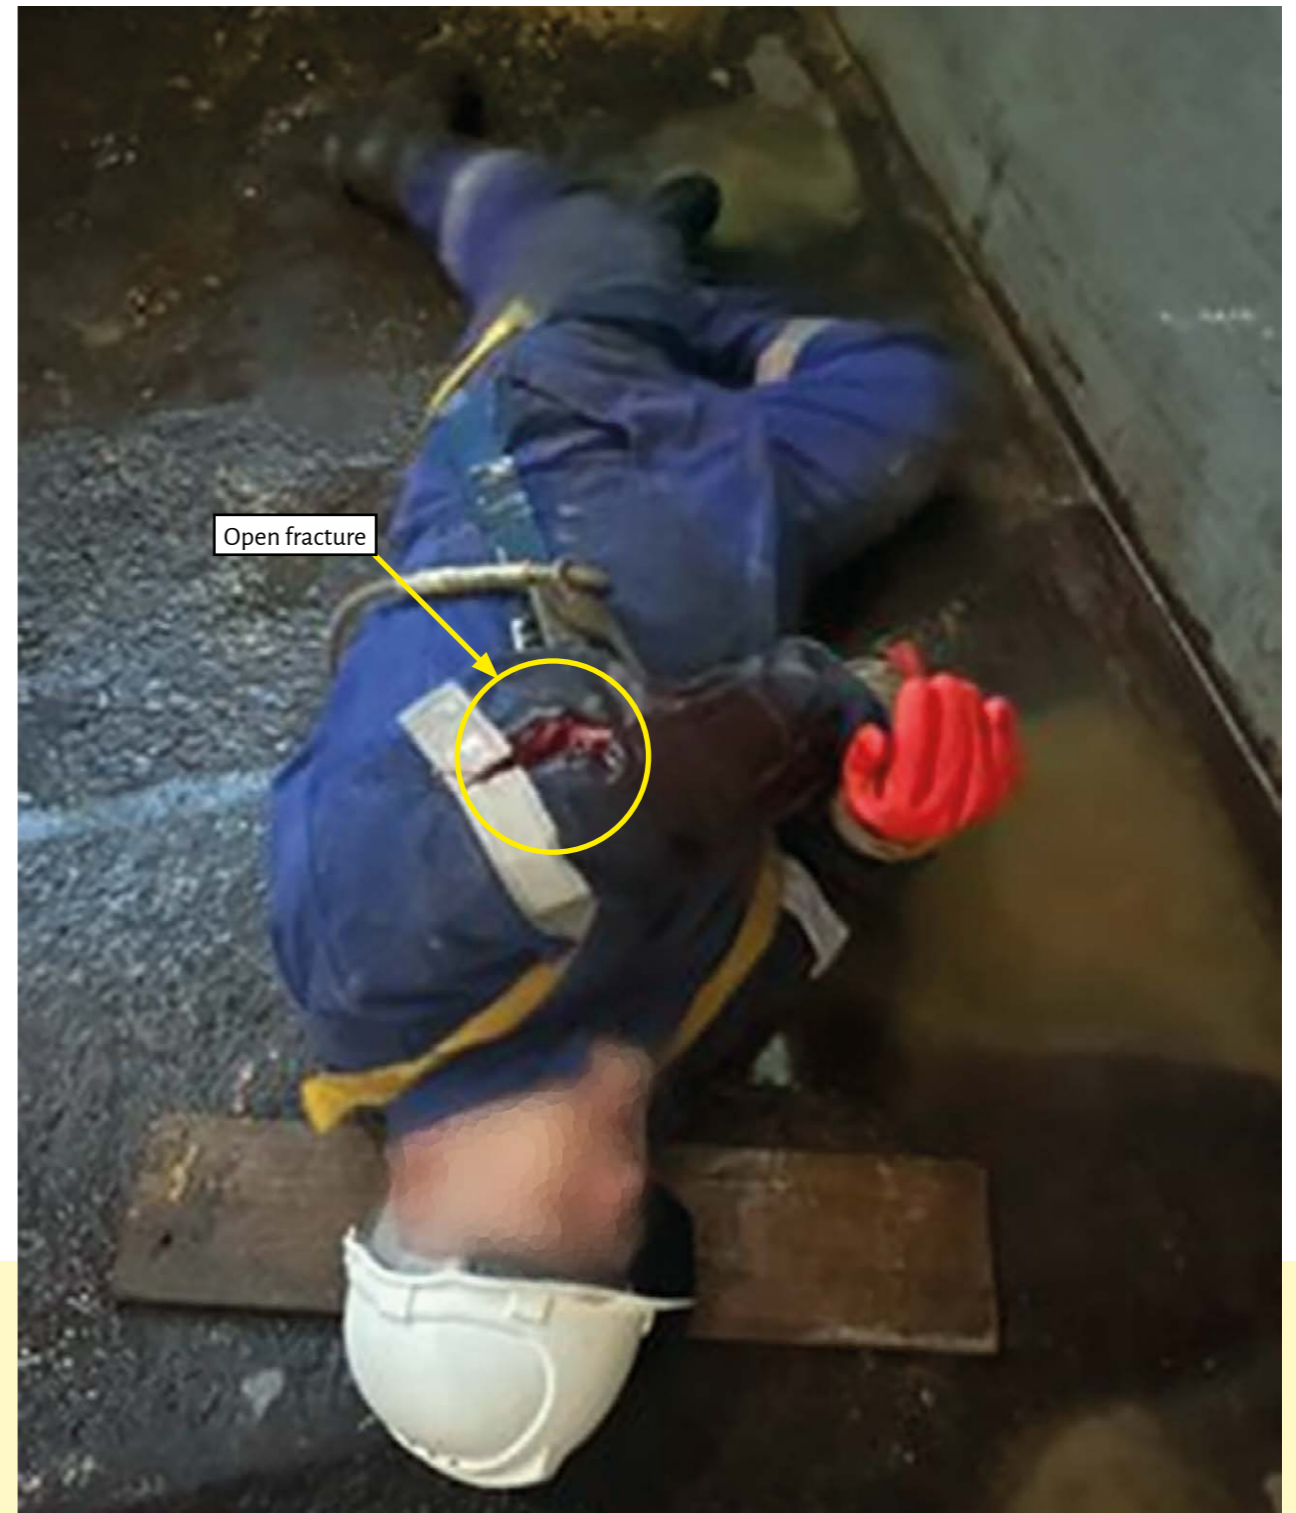
before the safety hook could be attached to a securing point. The AB fell to the hold bottom, resulting in an open fracture to their upper arm (Figure 2).

Figure 2: The injured AB lying in the hold

- Risk** → It was inappropriate for the AB to be working at height in the dark and rain with no shore floodlights and only a single spotlight at the aft end of the hold. The ship's working at height risk assessments did not include such factors, demonstrating that all realistic scenarios in which crew might be expected to work had not been considered and resulting in documentation that was of little safety value.

- Procedure** → The ship did not have procedures or equipment to recover an injured person from the cargo hold. Without suitable crew training and recovery equipment, it is possible for a survivable injury to become a fatality. Think about what could go wrong and then plan and be prepared to respond in the event that it does; it could be you lying at the bottom of the hold in serious pain.
