Lessons Learned 18

Incident: Health hazard to a dock worker due to electric shock when connecting a refrigerated container on board a container ship

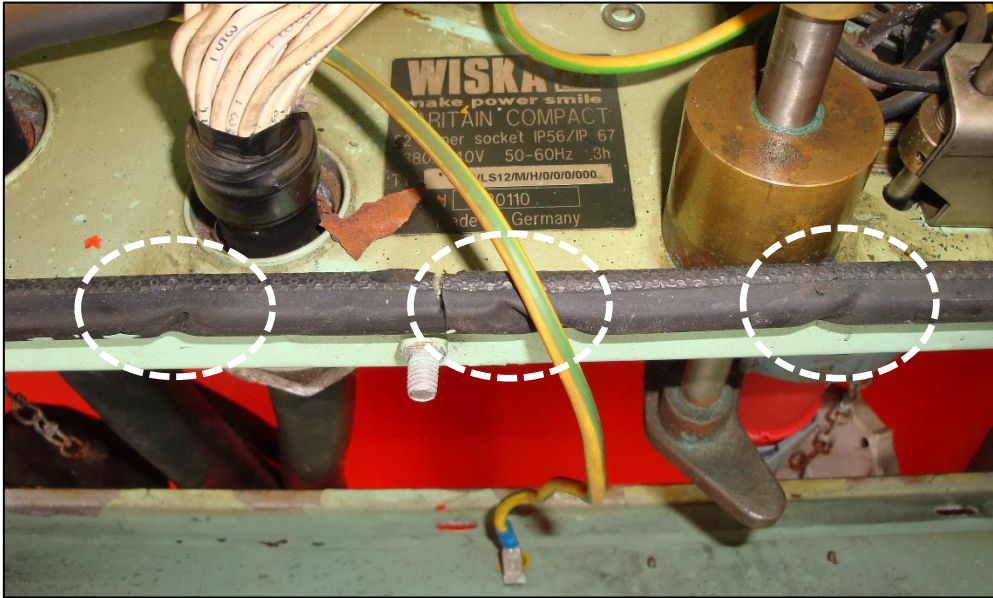
- The rubber seal of the switch box housing, which was firmly closed with a screwed cover, was damaged and therefore insufficiently preventing the ingress of moisture.
- This could lead to the formation of a so-called creepage distance formation in the housing, which could trigger a fault current.

Figure 2: Localized pressure points in the rubber seal of the switch box housing

- Planning, implementation and documentation of regular inspections of the technical condition of all terminal/switch boxes for refrigerated containers by the relevant qualified technical personnel on board
- Inclusion of the inspection routines in the ship's maintenance system
- Immediate decommissioning of defective terminal/switch boxes until they have been professionally repaired
- Inspection of the terminal/switch boxes by a shore-based service company at fixed intervals
- Greater consideration of the (random) inspection of the technical condition of reefer container terminal/switch boxes when surveys are carried out by the classification societies and during Port State Controls

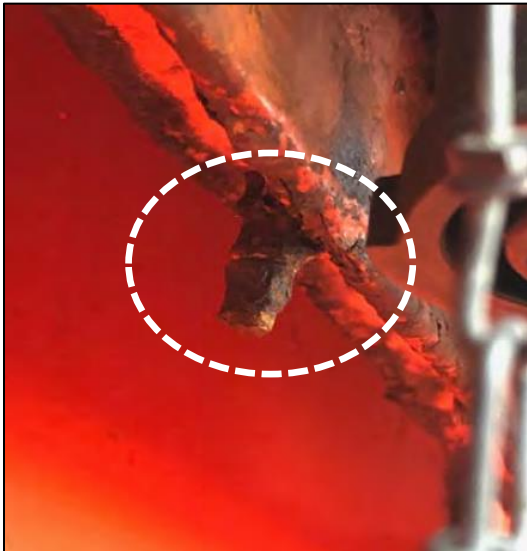
- The PE conductor (earthing connection) was severely impaired in its functionality due to corrosion and/or loose contact.
- The fault current caused by the creepage distance was therefore not (exclusively) discharged directly via the PE conductor in the direction of the ship's hull. Instead, the fault current flowed at least partially through the body of the dock worker during contact with the switch box housing, who suffered an electric shock as a result.

Figure 3: Corroded earthing connection

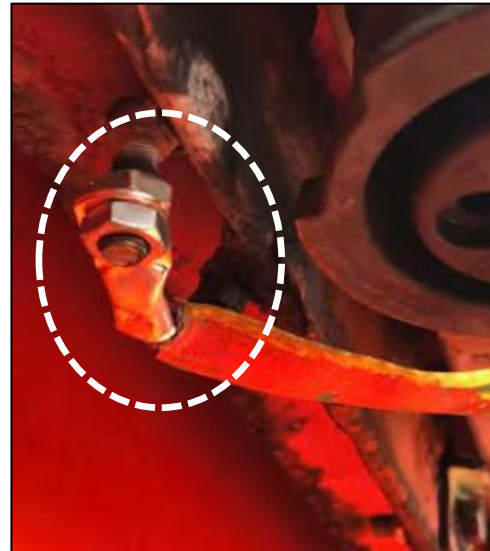
Figure 4: Earthing connection after renewal
