15 September 2024

# Safety Bulletin 9 /2024

## Damaged crane wires

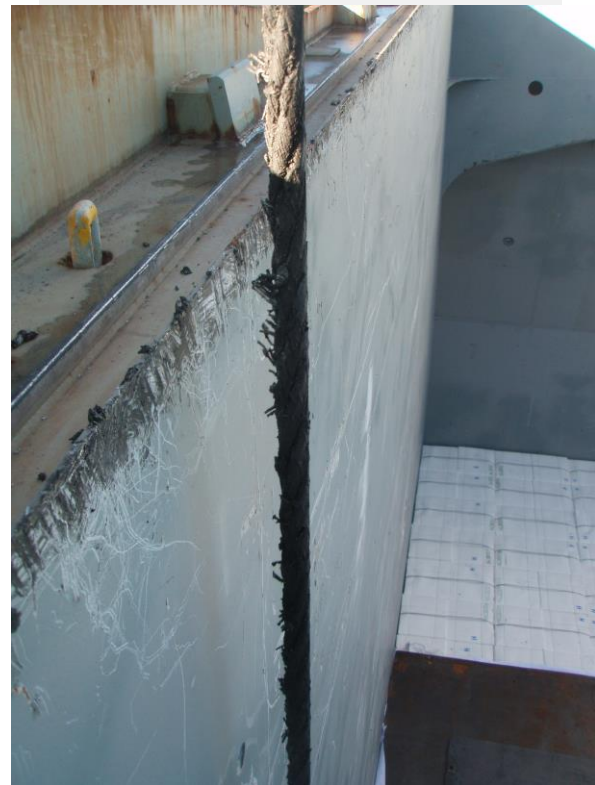
Example of extreme wire damage. Grease marks are clearly visible on the coaming, the wire rope has been dragged over the coaming repetitively.

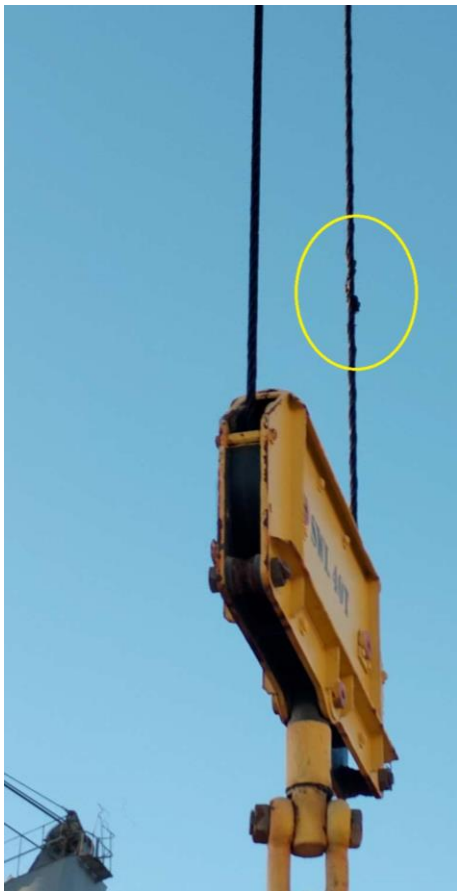
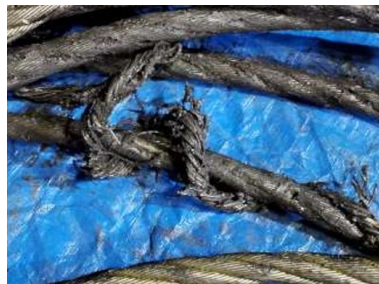
**Case 2:**

A crew member spotted wire damage during loading (yellow circle), and alerted the crane operator.

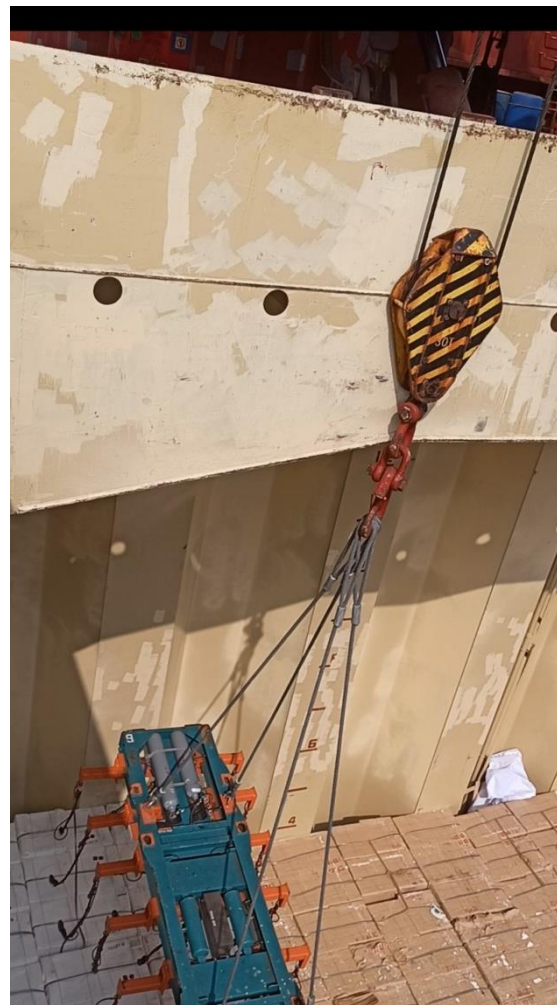
**Case 1:**

The wire was touching the overhang. Crew intervened and stopped the operation.
