# LESSONS LEARNT: NEAR MISS - UNPLANNED LIFT DESCENT

LOCATION: LIVERPOOL – CONTAINER TERMINAL, T2 STS CRANE QC06

Ref: LL 08 24

## Unplanned lift descent

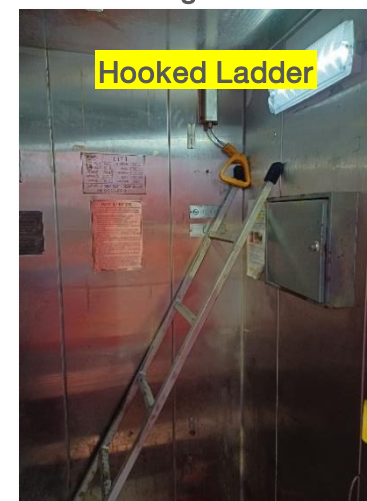
Image 2

The shuddering of the lift ascending caused the ladder to be released completely from the latch (Image 3), falling forwards and making contact with the emergency brake release (Image 2) which is designed to allow the lift to descend in situations where power is lost and personnel are stuck inside.

- The ladder was not sufficiently secured, the latch was not robust enough to prevent accidental release.
- The brake release handle was not suitably protected from accidental contact.
- SWL details in the lift should have included maximum number of persons in addition to the SWL.

- Ladder will be secured on 2 permanent hooks, requiring the ladder to be lifted off before use.
- Brake release handle will be protected by metal containment to prevent accidental engagement.
- Signs will be affixed to lift stating **Maximum 3 Persons**

In addition, the brake handle was inspected by Alimak (the lift maintenance company) and given the all clear.

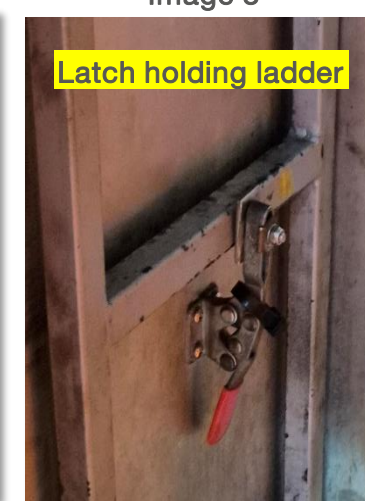
Image 3

The external engineers had packed the lift with too many people and one of them had inadvertently knocked the latch that secured the emergency ladder.

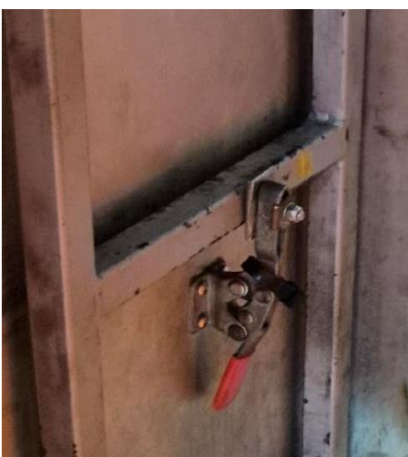
Image 1

The external engineers had accidentally knocked the latch securing the emergency ladder inside the lift car. The shuddering of the lift ascending had caused the ladder to be released completely from the latch (image 1), falling forwards and making contact with the emergency brake release (image 2) which is designed to allow the lift to descend in situations where power is lost, and personnel are stuck inside.

- Ensure SWL details include a maximum number of persons the lift can hold and affix signs in the lift clearly stating so.
- Secure emergency ladders on two permanent hooks, requiring the ladder to be lifted off before use.
- Protect the brake release handle with metal containment to prevent accidental engagement.
- Ensure brake handle has been inspected and approved by a lift maintenance company.

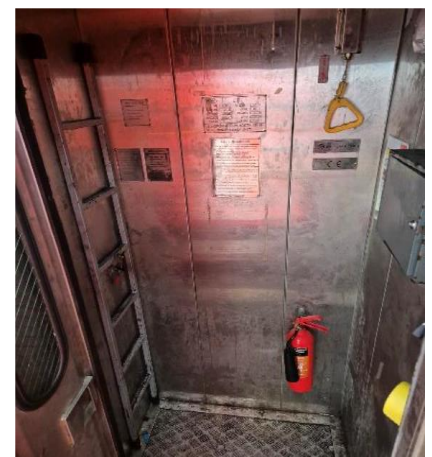
Image 3

- External engineers packed the lift with too many people resulting in one of them inadvertently knocking the latch that secured the emergency ladder.
- The ladder was not sufficiently secured in stowed position (image 3), and the latch was not robust enough to prevent accidental release.
- The brake release handle was not suitably protected from accidental contact.
- SWL (Safe Working Load) details in the lift did not include a maximum number of persons.
