Safety Alert

Ref No: SA-014-2024

Ship's gangway fell from quay

DPWS SAFETY BULLETIN – 02 October 2024

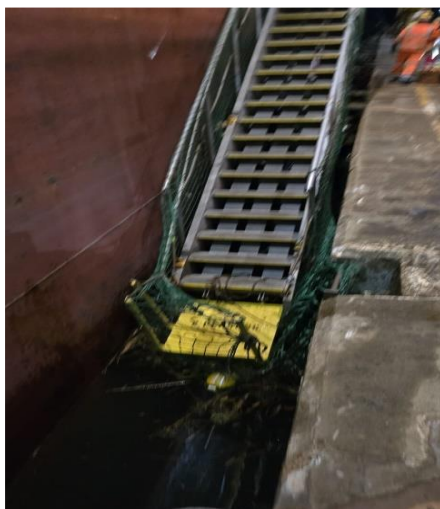
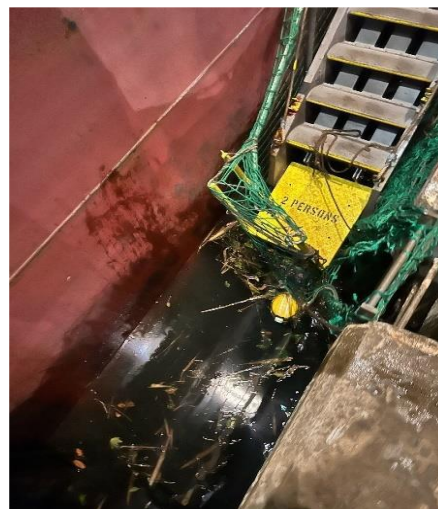
Movement of the vessel on the tidal berth resulted in the ship's gangway resting partially over the quayside ladder void. As the five lashers were ascending the gangway, the gangway moved from the quay wall, swinging back to the side of the vessel and dropping approximately 2-3 meters below the quay wall (images below).

- Tidal movement of the vessel caused the gangway to move position, and the gangway roller encroached on the ladder void, causing it to be less stable.
- Vessel gangway procedure requiring supervision at all times, was not followed. At the time of incident, the gangway hoist wires were slack enough to for the gangway to drop approximately three meters.
- Markings on the quayside, around the ladder were faded and of insufficient colour and size to raise awareness of potential quayside hazard.
- The IP was not wearing his chinstrap when going up the gangway resulting in losing his helmet during the fall into the water, where he narrowly missed striking the quayside fender.
- A large painted sign showing the maximum load of the gangway was faded.
- There was no life buoy present at the lower part of the gangway supplied by the vessel as per HSE ACOP.

- Position vessel gangways away from ladder voids.
- Review operations to ensure that written procedures are followed in practice.
- All employees must wear PPE correctly.
- All signs on the vessel and on the gangway must clear in providing information regarding maximum load, capacity and potential hazards.
- Carry out pre-work gangway and vessel checks before vessel operations commence and at suitable intervals throughout.
- Encourage the use of stop work authorities if unsafe situations are observed.
- Review markings for quayside hazards such as ladder voids to ensure they are suitable.

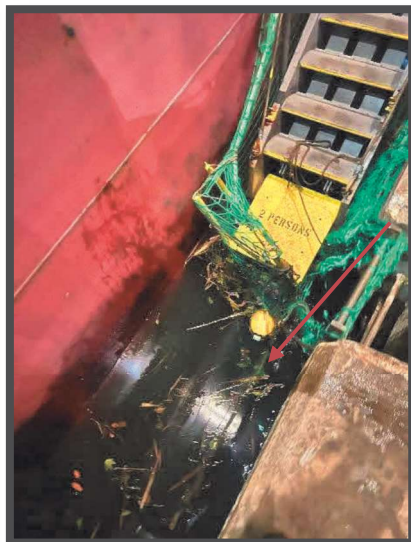
Red arrows show direction the gangway fell away from quay wall – approx. 2.5mtrs towards the water.

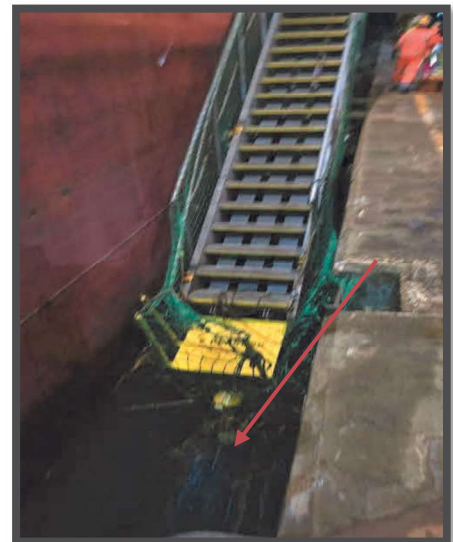
Photos of gangway post incident. There is no CCTV available of the incident.
