1. Safety Alert: Falling twistlocks during operations

Falling twistlocks have the potential kill or severely injure people. This safety alert combines several incidents to focus on this hazard.

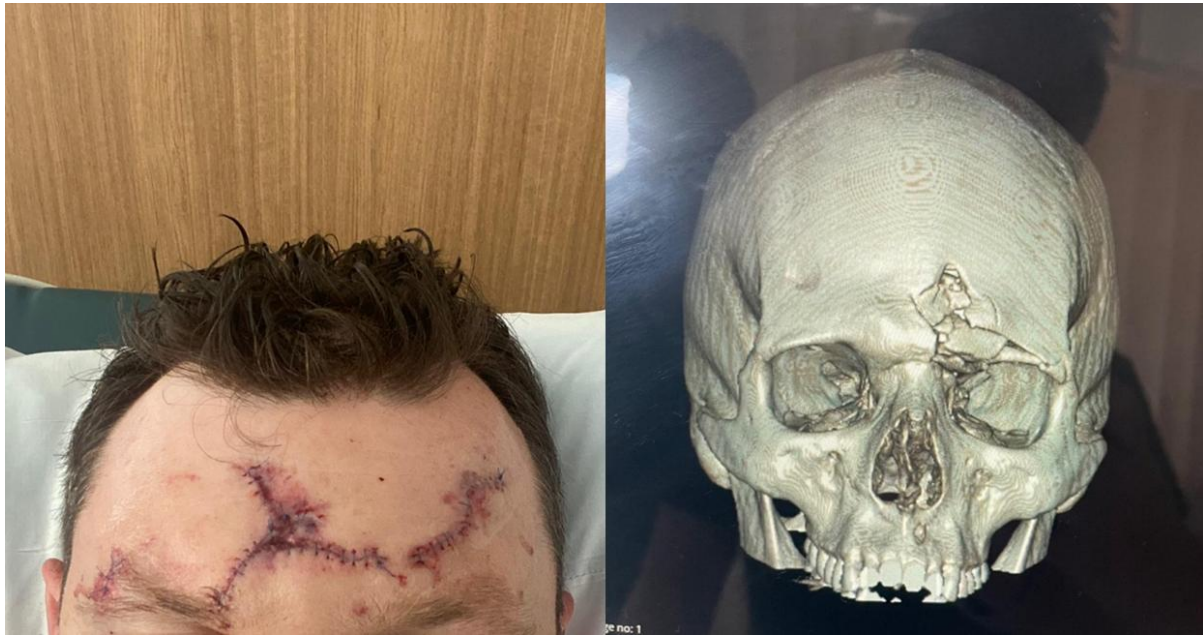
The investigation concluded that the twistlock dislodged from a five high fitting, striking the vessel team leader. The twistlock became dislodged because the twistlock locator pin failed while loading into a blind cell on deck.

Figure 1 - injuries sustained as a result of being struck by falling twistlock. See “The National Tribune 2024, Falling dislodged auto twistlock struck deckforeman / team leader”
<https://www.nationaltribune.com.au/falling-dislodged-auto-twistlock-struck-deckforeman-team-leader/>

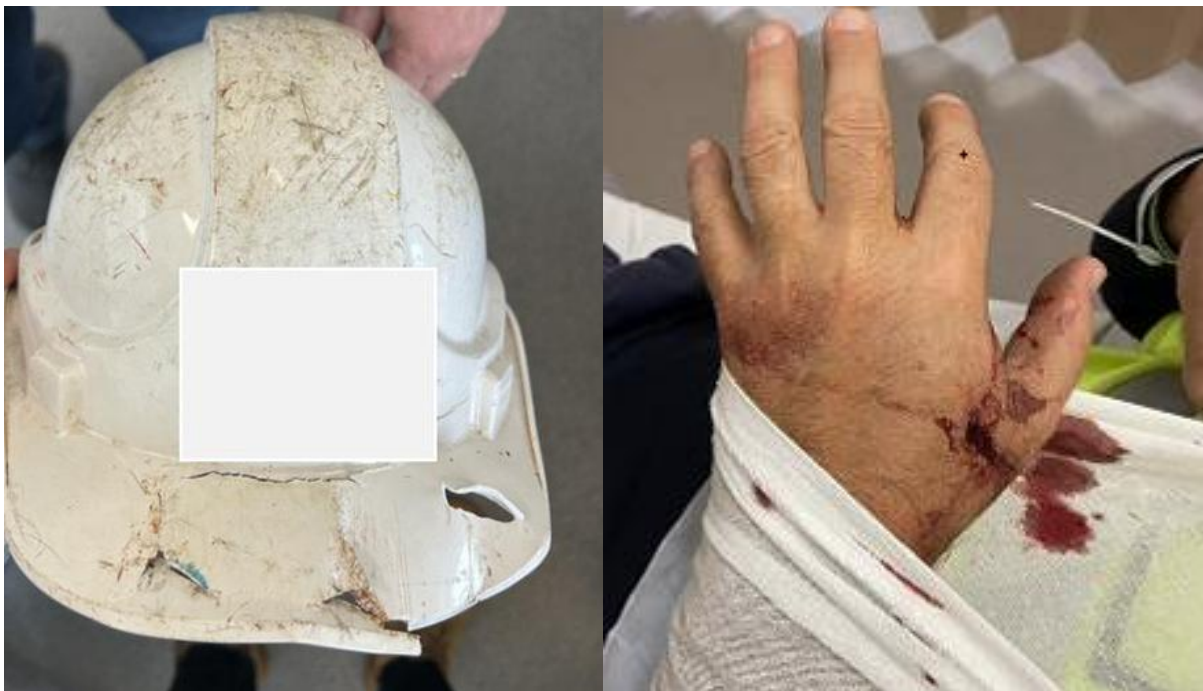
Figure 2 - protective headwear and further injury from the same incident

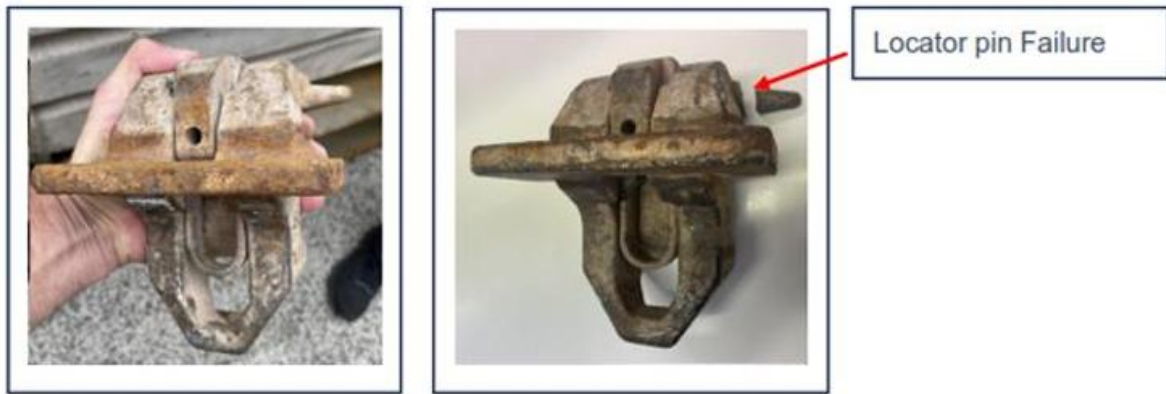
Figure 3 - failed twistlock

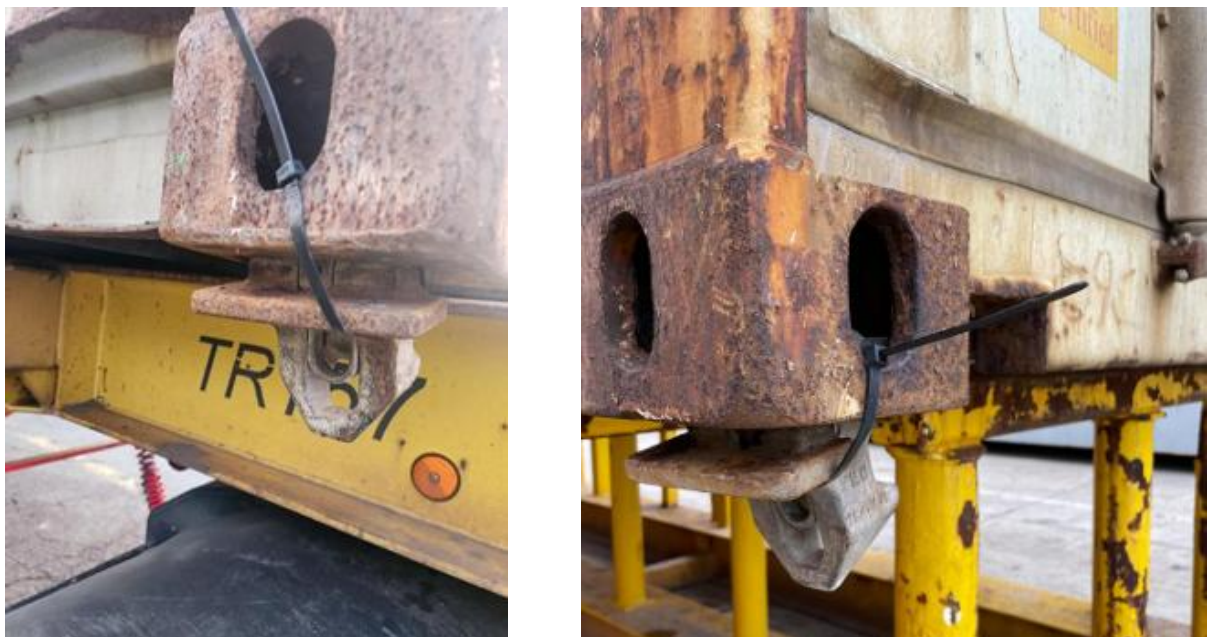
A member terminal has identified multiple inappropriate securing workarounds. Three examples of such are shown in the images below. Near misses of twistlocks dislodging on deck have been observed; more may be going unreported.

Figure 4 - non-conforming twistlock securing workaround

Prohibited Workarounds: makeshift fixes (e.g., cable ties, timber, paper) to secure twistlocks are strictly forbidden.

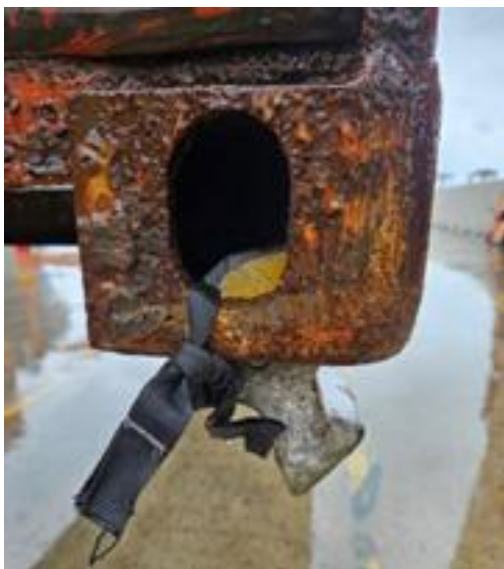
Figure 5 – non-conforming twistlock workaround

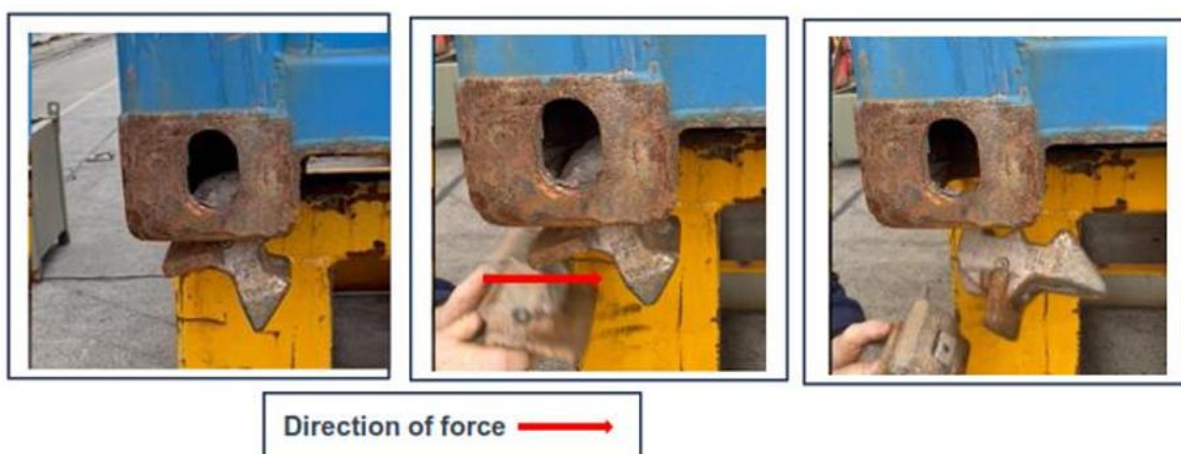
- Risk of Twistlock Failure: Older twistlocks combined with worn corner fittings may not secure properly, increasing the risk of falling objects during movement or deck positioning.
- Ricochet Hazard: Even with procedures keeping personnel at a safe distance, twistlocks can ricochet upon impact.
- Fatality Potential: These failures create a high-risk, potentially fatal scenario for personnel.

Figure 6 – example of movement giving rise to ‘fall out’ risk from defective corner fitting

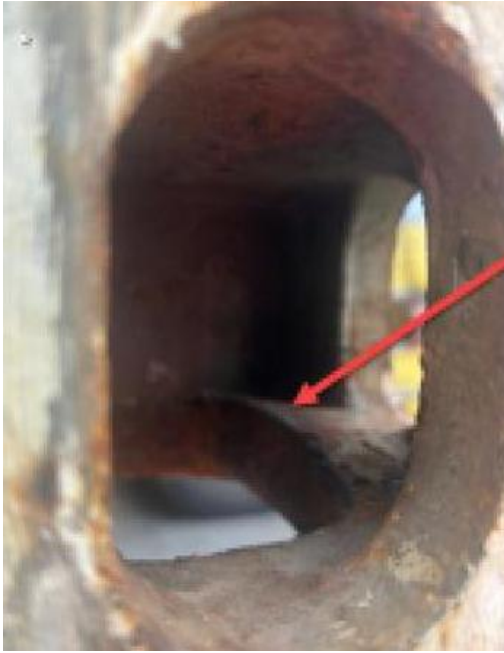
Figure 7 – example defective corner fitting/pocket

Quarantine: Containers with out-of-tolerance corner fittings are quarantined and removed from the terminal.

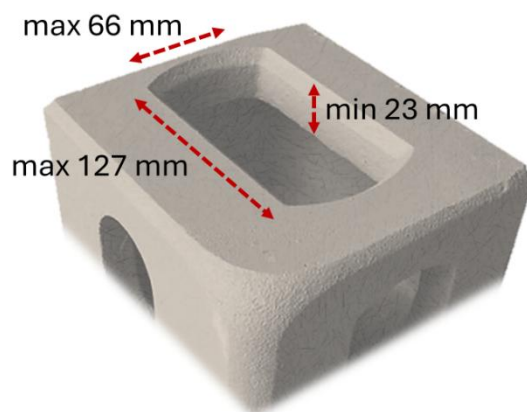
The [Convention for Safe Containers Code](#) (CSC) code states that full engagement of securing or lifting fittings is precluded if there is any deformation of the fitting beyond 5mm from its original plane, any aperture width greater than 66mm, any aperture length greater than 127mm or any reduction in thickness of the plate containing the top aperture that makes it less than 23mm thick.

Figure 8 - corner fitting aperture critical dimensions

Do not wait for corner fitting apertures to reach critical dimensions

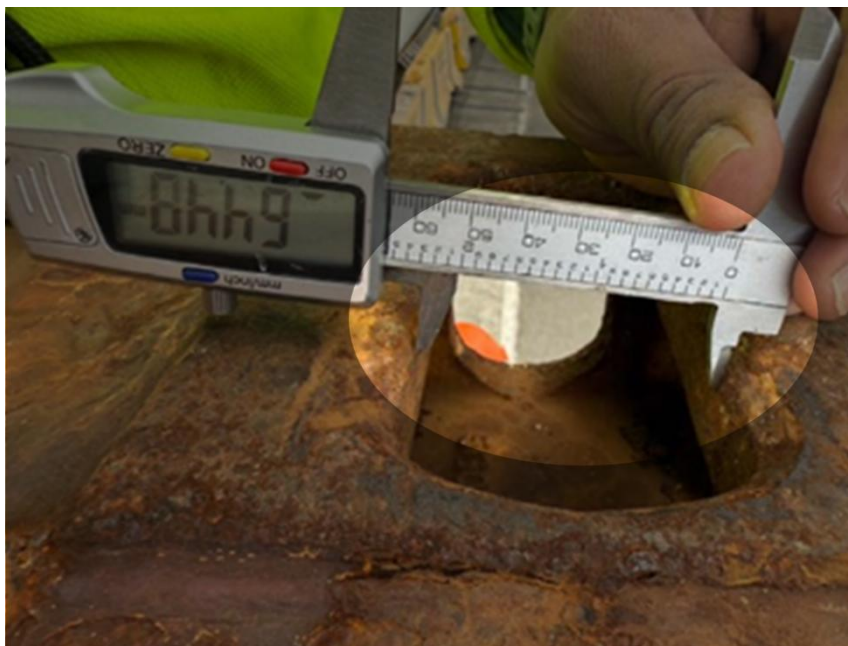
Figure 9 - example inspection of corner fitting aperture

Callipers may be used to determine that the aperture remains within CSC critical dimension tolerances.

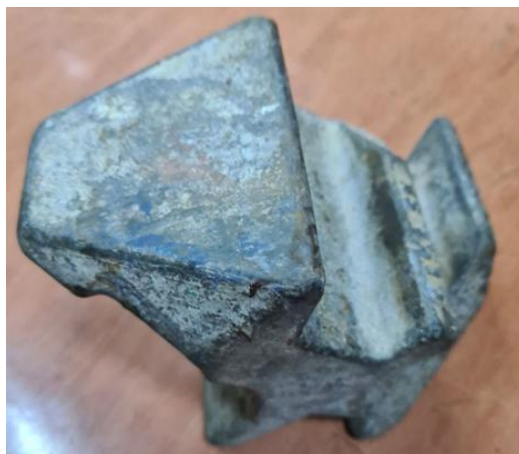
6.2. In 2021 the twistlock in the image below struck and killed an operative at a terminal

Figure 11 - Twistlock responsible for a work fatality
