REPUBLIC OF LIBERIA
Liberia Maritime Authority

**Very Serious Marine Casualty Investigation Report
into the death of an Able Seafarer Deck on
M/V EUROSTAR (IMO 9546203)
on April 10, 2024**

**PUBLISHED BY THE LIBERIA MARITIME AUTHORITY
December 24, 2025
Dulles, Virginia
USA**

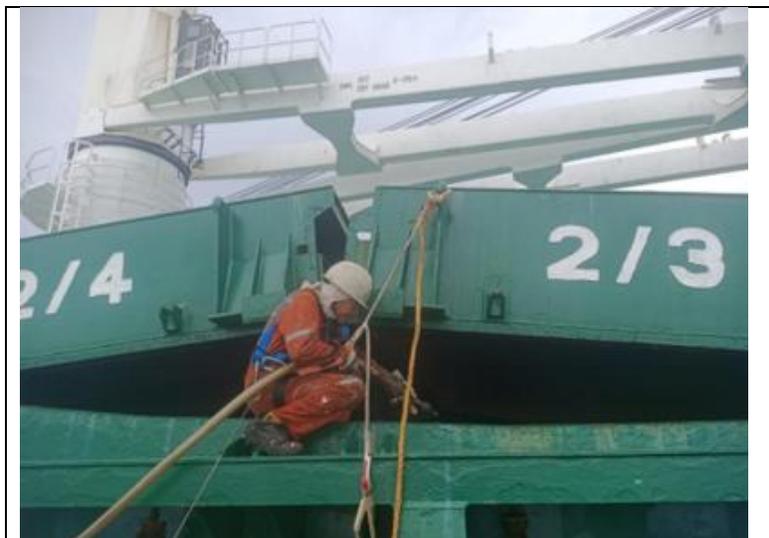
Figure 1: Simulated position of ASD1 during hatch coaming cleaning operation on Cargo Hold No. 2.

0903 LT, ASD1 was positioned on the starboard hatch coaming, assisted by an OS. ASD1 instructed the OS to go inform ASD2 to clean both sides of the hatch coaming simultaneously. The OS informed the ASD2 accordingly and shortly thereafter, the OS returned to ASD1's location but did not find him on the cargo hatch coaming. Upon looking down into Cargo Hold No. 2, the OS observed ASD1 lying on the tank top.

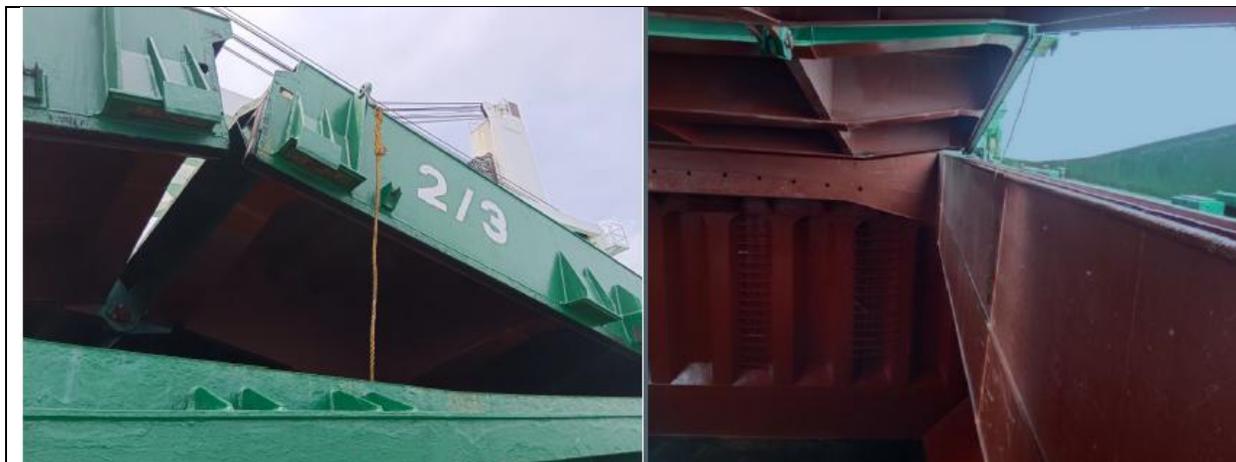
Figure 2: Extension rope secured to the hatch cover pad eye following the incident.

The probable cause of the casualty was a fall from height into Cargo Hold No. 2 by the ASD1 while working on the starboard hatch coaming, likely occurring during attachment or repositioning of the safety harness without a backup safety line, in conditions with wet surfaces and insufficient on-scene supervision.

- Mandate two-point fall protection: primary harness and independent backup lifeline whenever connecting/disconnecting at height.
- Prohibit reliance on non-certified extension ropes; require approved slings/anchorage devices rated for fall arrest.
- Eliminate standing on hatch coamings where practicable; employ work platforms, guard-rails, bosun's chairs/cradles, or alternative cleaning methods that remove the exposure.
