15 August 2026

# Safety Bulletin 8 /2026

## Crane wire damaged

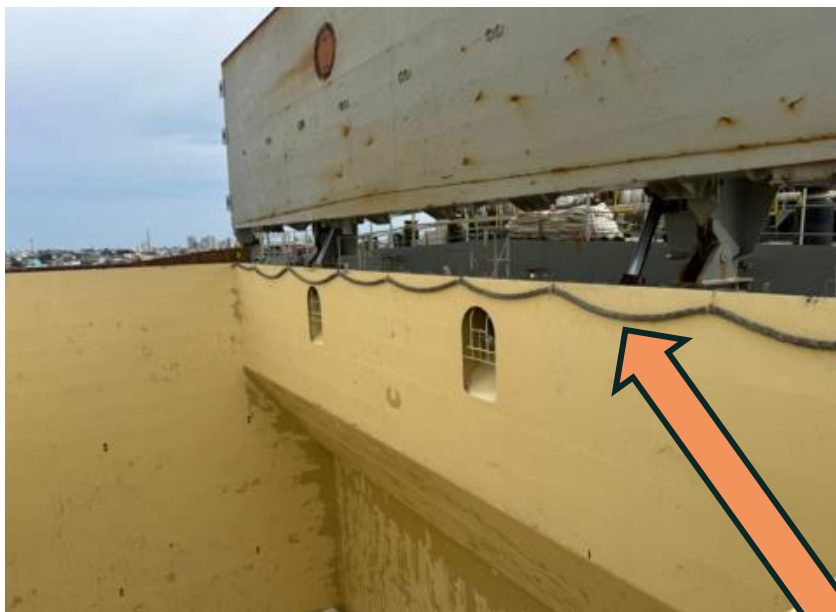
This cargo hold has an overhang, which increases the risk of the wire being dragged against the coaming. The crew has put up a mooring rope, to protect the bulkhead and alert the crane driver if the wire is too close.

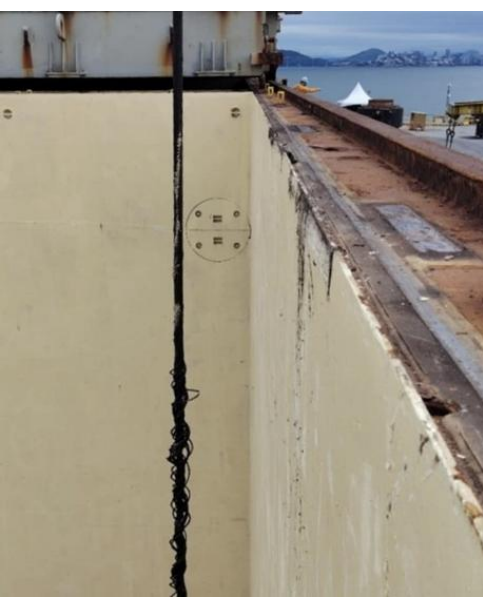
During unloading of steel slabs, several wire strands broke. Fortunately, the core of the wire did not break. Crew observed the incident and immediately alerted the crane driver.

In the picture above, the grease marks clearly show that the wire has been dragged against the bulkhead. The damaged part of the wire was sent to a laboratory to verify the root cause.

- There were no injuries. The damaged wire was replaced.
- Potential fatality from dropped objects, if the wire had snapped. Stevedores were working inside the hold at the time of the incident.

- If you see the wire rubbing against the hatch coaming, hatch cover or any other part of the vessel: Stop the operation.
- There is no single measure which can eliminate the risk for all operations, but in most situations practical solutions can be found. Examples include:
  - Using a different size or type of lifting frame.
  - Using forklifts to re-position cargo inside the hold.
  - Protecting the bulkhead with mooring ropes.
