15 August 2023

Safety Bulletin 8 /2023

Crush injuries

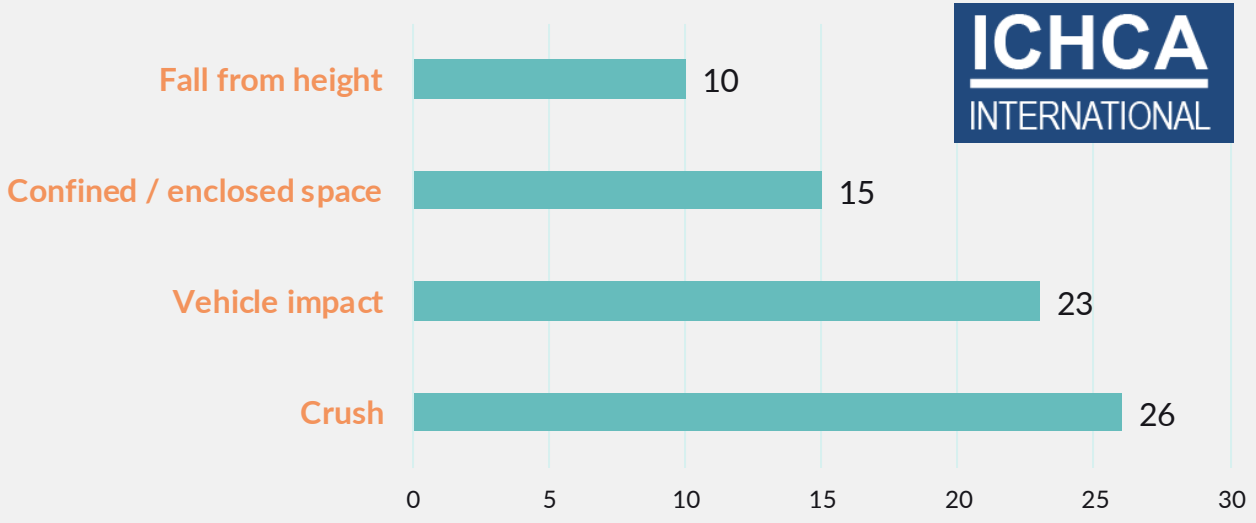
Top 4 causes of shore worker fatalities (in %)

A recent ICHCA study into fatalities shows that 26 % are the result of crush injuries. These are incidents where a person is caught between two pieces of cargo, or cargo and a fixed object, such as a bulkhead.

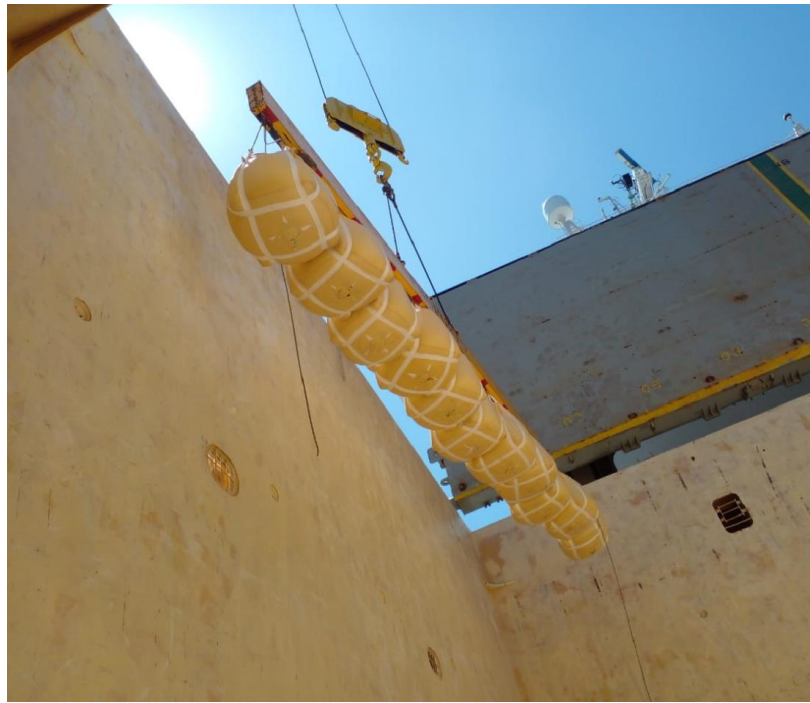
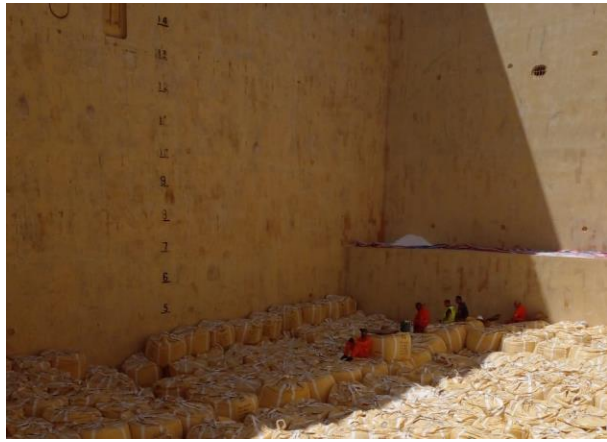
Stevedores were inside the cargo hold, hooking up bags to the spreader beam.

Big bags of soda ash were discharged. A stevedore was standing between the spreader beam and the bulkhead, when there was a sudden, unexpected movement of the beam. The stevedore's rib cage was momentarily pressed between the beam and the bulkhead.

In this case the stevedore suffered minor injuries. He was conscious when taken to hospital for examination. Considering the weight of the spreader, there was a potential for much more severe injuries.

- Always be aware of your surroundings. Identify potential hazards, including moving objects.
