Safety Bulletin 10/2023

Crane operator and signaller

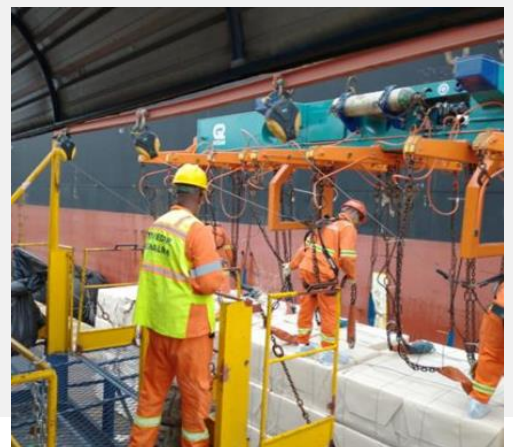
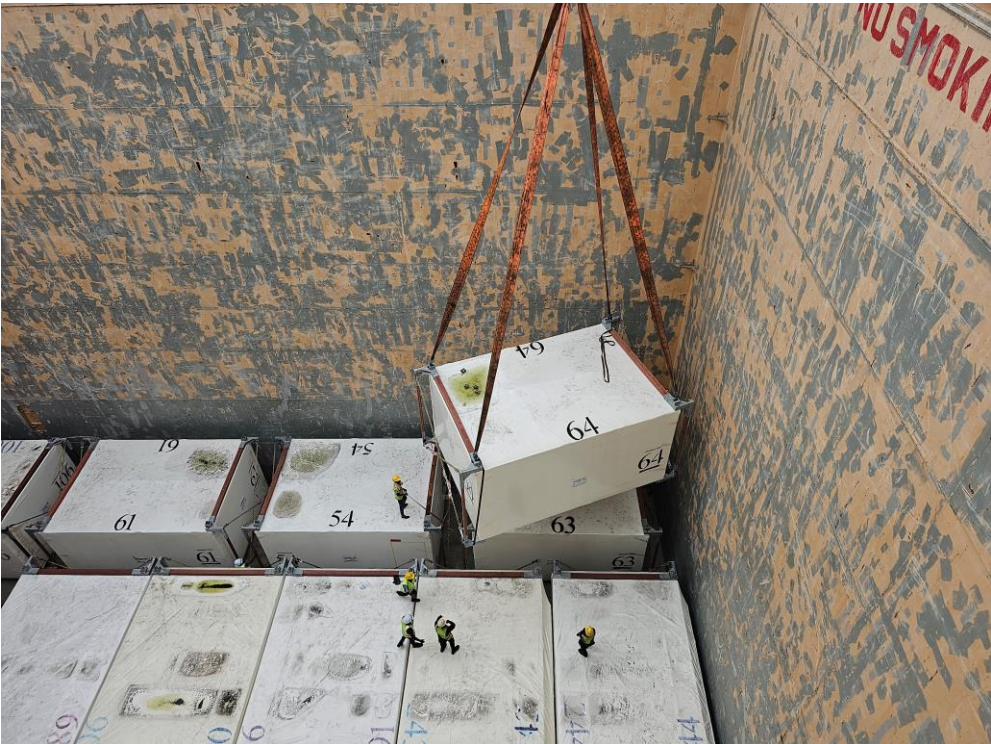
Case 2 and 3: Two similar incidents in only three days occurred in two Brazilian ports, during loading of pulp. Stevedores enter the top of the pulp bales from a fixed platform on the quay, to connect the hooks (pictures left and below). The required safety harness was in use and connected to the platform. But in both cases the safety line was entangled in the hook chain when the crane operator lifted the cargo. The stevedores were pulled along with the lift and injured.

Two stevedores got entangled with the lift.

- While other causes also contributed to these 4 incidents, there was a lack of communication between the signaller and crane operator in all of them.
- The signaller must stop operations when persons are in an unsafe position, and check that everyone is well clear before giving the signal to start lifting.
- The crane operator must follow the signaller’s orders.
- Follow this life-saving rule: **Identify danger zones.** Never position yourself between the bulkhead and moving cargo.

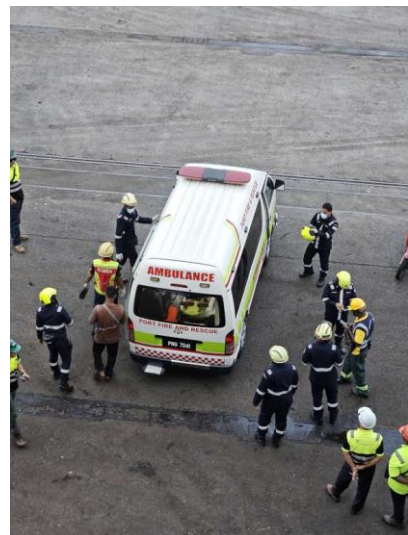
Case 4: During loading of housing modules, two stevedores were caught between cargo and bulkhead. The cargo was being suspended to adjust the position of dunnage below, when it moved in a horizontal direction. One stevedore narrowly escaped. The other was saw what was about to happen and braced himself for the impact. The cargo hit his arm and he then fell backwards and hit an open access door behind him. The stevedore was taken to hospital.
