# Safety Bulletin 2 /2024

## Small tweak, big difference

### Heavy objects dropped

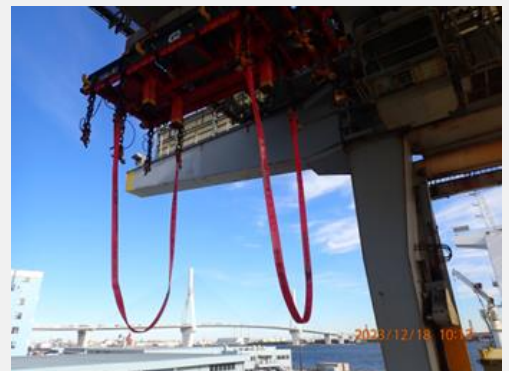
During what seemed like an ordinary lift, both slabs slipped out of the slings due to an abrupt crane movement. They dropped several meters.

- The dropped cargo units were recovered with assistance from divers and use of a shore crane.
- There was minor damage to the vessel and quay.
- Potential fatality if dropped cargo hit stevedores, crew or other persons in the area.

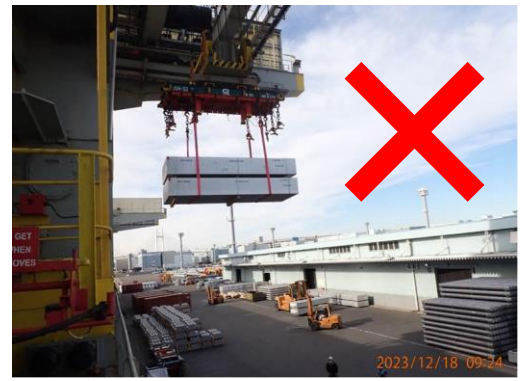
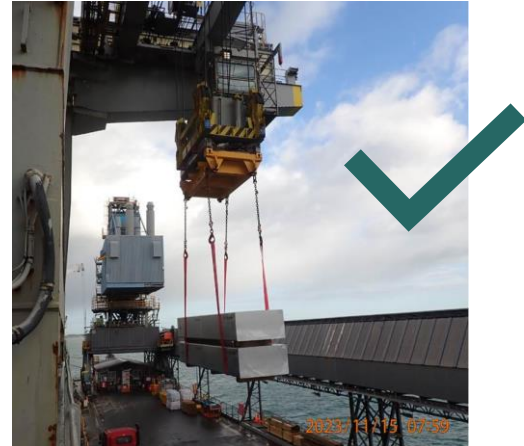
The crane's direction of travel is abeam, not fore-and aft. Abrupt crane movements can always occur, because of a mistake by the crane operator or a technical malfunction. If it happens, the cargo is much more likely to slide out of the slings, if the direction of the cargo is as shown in the top right corner.

- Consider the orientation of slabs, and all other types of cargo. Use the safer option, even if it adds a few seconds to each lifting operation.
- Assess risk. Sometimes a minor tweak in working method can significantly reduce risk. Having more than one safety barrier will ensure that a single human error or a minor technical malfunction does not have catastrophic consequences.
- Never walk under a suspended load. Make it a habit to walk on the sea-side when the vessel is alongside. Avoid the side facing the quay, where cargo operations are ongoing.
