Safety Bulletin 05 /2026

A new workplace every day

Know your vessel

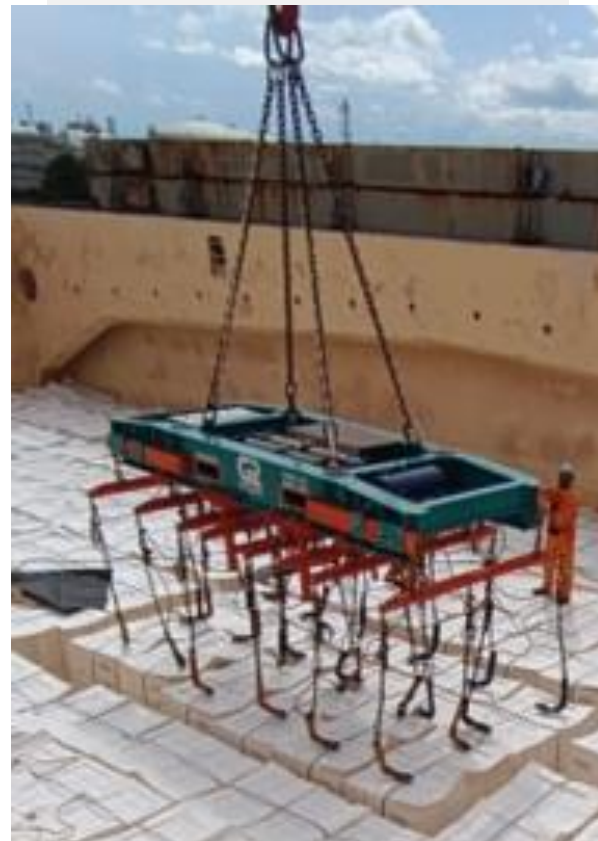
Loading: 6 x 2 pulp units per lift.

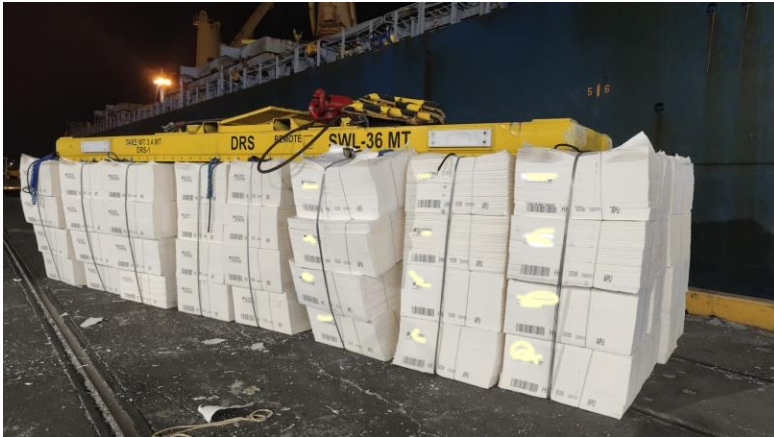
This is the same cargo shown on the previous page, now at the port of discharge. The hoisting wire broke, and the cargo, frame and hook dropped down on the quay.

Immediate cause: Stevedores made a human error and hooked up too many units to the frame: 8 x 2 units, instead of 6 x 2.

The combined weight of the 16 units (32 t) and the spreader (3.4 t) was 35.4 t, above the 30 t Safe Working Load of the crane.

- Actual: Damage to the crane hoisting wire, which was replaced.
- Potential: Fatal injuries to stevedores, crew or any other person working in the area, either on board or on the quayside.

- This vessel had never been to the discharging port before, while other vessels with higher capacity cranes call this port frequently.
- The root cause of this incident is yet to be identified. It is always good practice to seek and share insights about the vessel and the cargo operation, at the onboard safety meeting. Make sure all stevedores, on every shift, know the limitations of the vessel.
