# Navigating Safety within Ports and Harbours

## Fall from vertical quayside ladder has near-fatal consequences

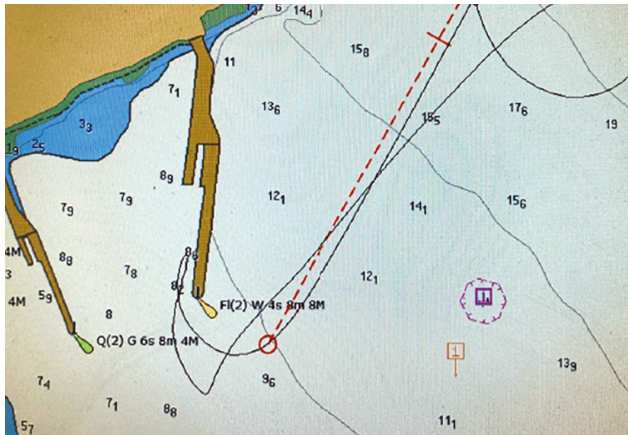
Port authorities are responsible for managing vessel traffic, and they would have been aware of the ferry's scheduled arrival time. Cruise vessels too operate to an itinerary but better co-ordination between the port and the cruise ship would have avoided this incident. This suggests either a breakdown in communication or the ferry's arrival was not correctly considered when the cruise ship planned its departure time. Radio procedure by the port authority was also ambiguous: was "You might want to slow up" a direction, or a recommendation?

In smaller ports, particularly those which are not staffed 24 hours a day, publish notices to mariners directing certain sizes or categories of vessels to broadcast their arrival and departure on the port's VHF working channel. This alerts other vessels of traffic in their vicinity and allows them to co-ordinate with each other. CHIRP encourages small ports to consider whether such a scheme would be appropriate in their harbour.

**Local Practices** – Port management must not leave marine operations to chance. Establish clear safety risk measures, and define procedures to clearly understand what is required for arriving and departing vessels at this port.
