# Entrapment by hatch cranes

Extended investigation after  
fatal entrapment on cargo ship

*The Hague, July 2022*

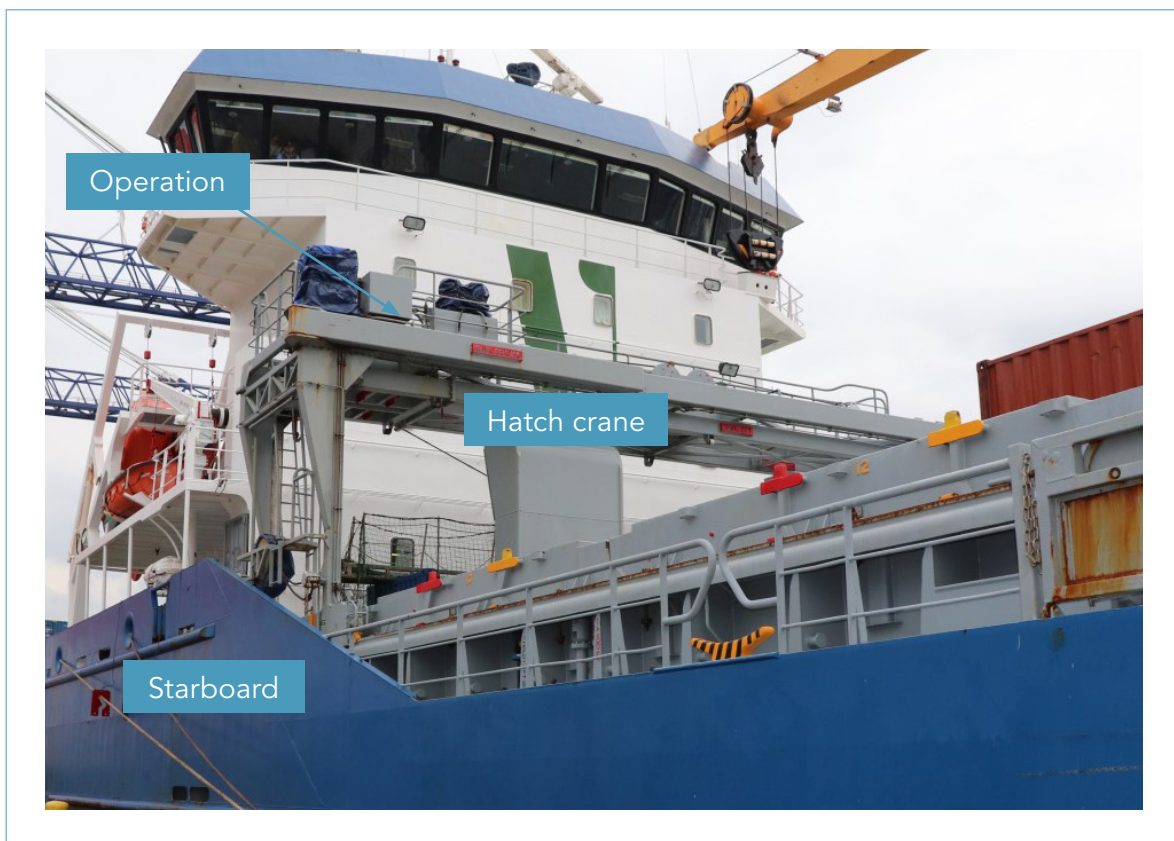
In the morning of 30 June 2018, in the port of St. Marc, Haiti, there was a fatal occurrence on board the Beauforce. A crew member of the Dutch merchant vessel got trapped between the moving hatch crane and the stacked hatches when he stepped from the hold entrance amidships onto the deck. At that time, the hatch crane was used to close the hatches of hold number 1.

Figure 1: Hatch crane in home position, seen from the shore (starboard).

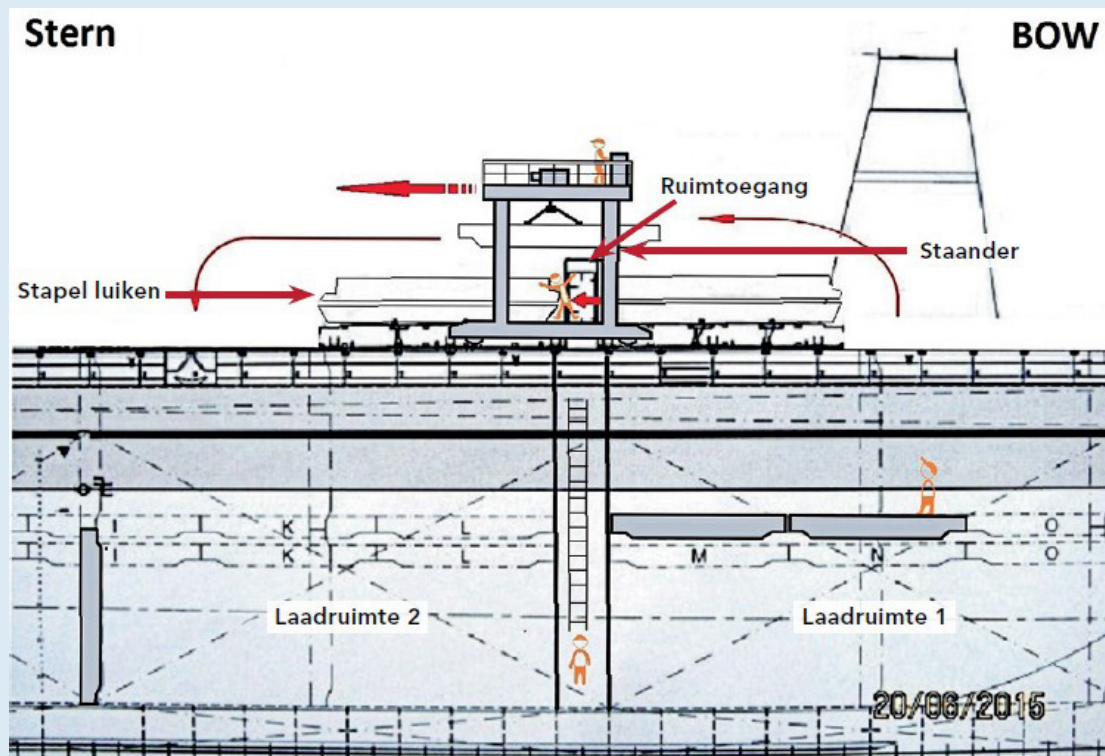
A hatch crane (also known as hatch cover gantry crane) is a moveable crane that mainly consists of two vertical supports and a horizontal transverse beam. The operator usually stands on top of the hatch crane and moves along with the crane during operation. Figure 2 shows the operator position and the direction of travel as it was at the moment of the occurrence on board of the *Beauforce* in 2015.

Figure 2: Illustration of the hatch crane. (Source: Focus Shipmanagement)

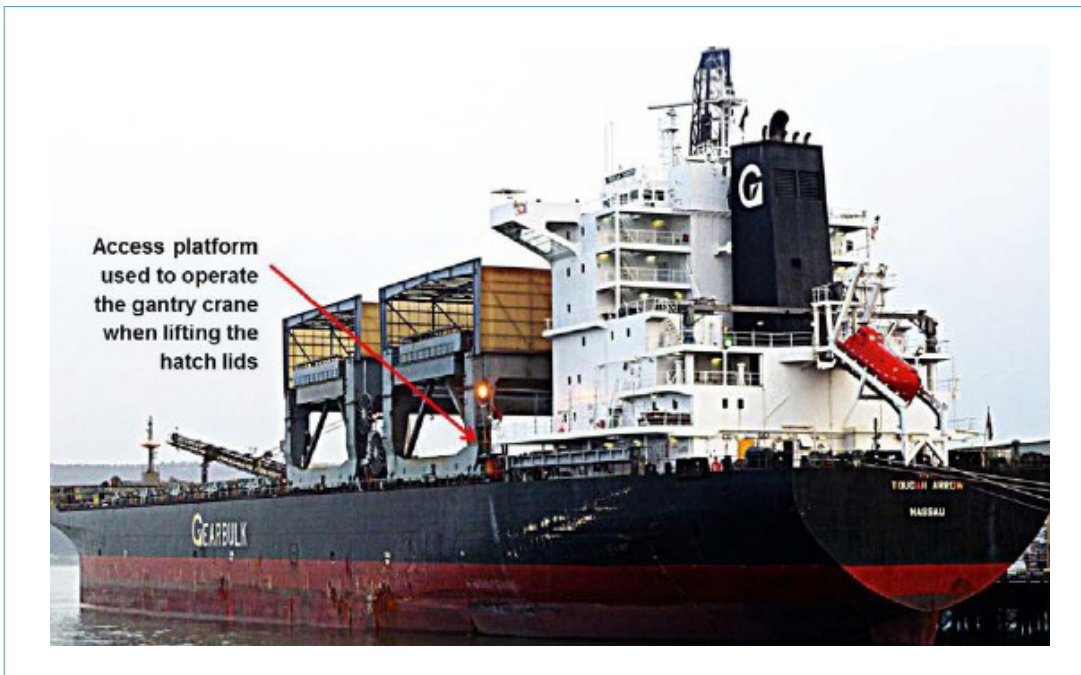
On 7 October 2013, on board of the cargo vessel Toucan Arrow in the port of Portland, Australia, a crew member became entrapped between the hatch crane and a hatch cover. A number of crew members were busy preparing the hatch crane for loading and unloading operations by stevedores which involved occasional movements of the hatch crane. After the hatch crane had been prepared for cargo operations, the crane operator was asked to move the crane over some distance in order to pick up some material. During these operations a crew member saw the victim lying injured on the deck and raised the alarm.

Figure 11: Toucan Arrow showing both hatch cranes. (Source: ATSB)

Nobody saw what happened, and therefore investigation by the Australian Transport Safety Bureau (ATSB) was not conclusive as to the actions of the crew member at the time of the occurrence. Tools and a new warning light were found close to the accident location. Partly on the basis of this finding, the ATSB concluded that the victim probably had the intention of replacing the defective warning light of the hatch crane and that he had climbed up two hatches in order to do so. On the basis of forensic evidence it is assumed that he became entrapped between the stacked hatches and the moving hatch crane.

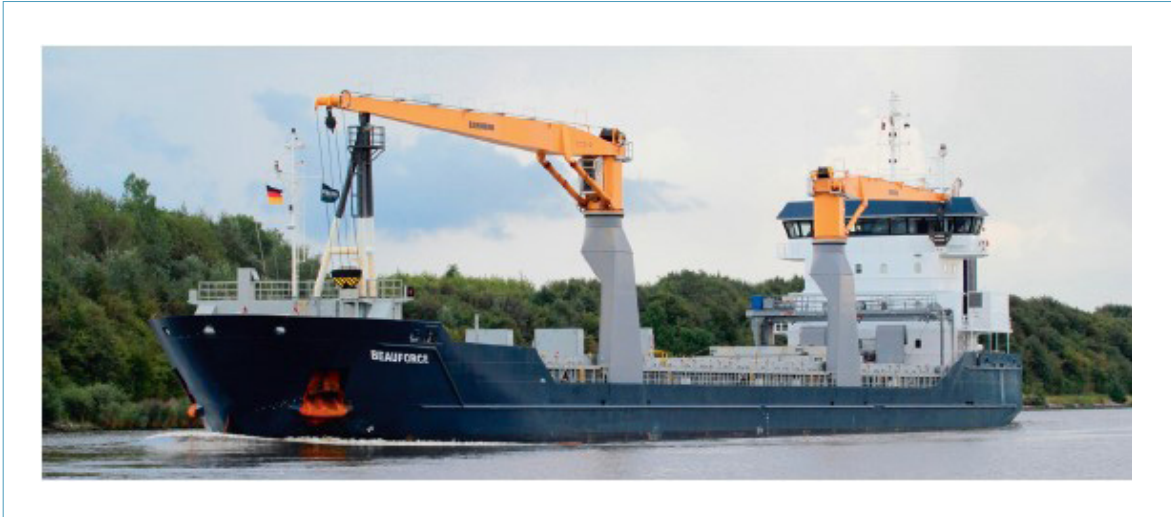
Tuesday 9 June 2015, a crew member of the Dutch cargo vessel Beauforce became entrapped by the hatch crane. At that moment the hatch crane was being used to move pontoons in order to prepare the cargo holds for taking on new cargo. The ship was at anchor awaiting passing through the Panama Canal.

Figure 13: Beauforce. (Source: Focus Shipmanagement BV)

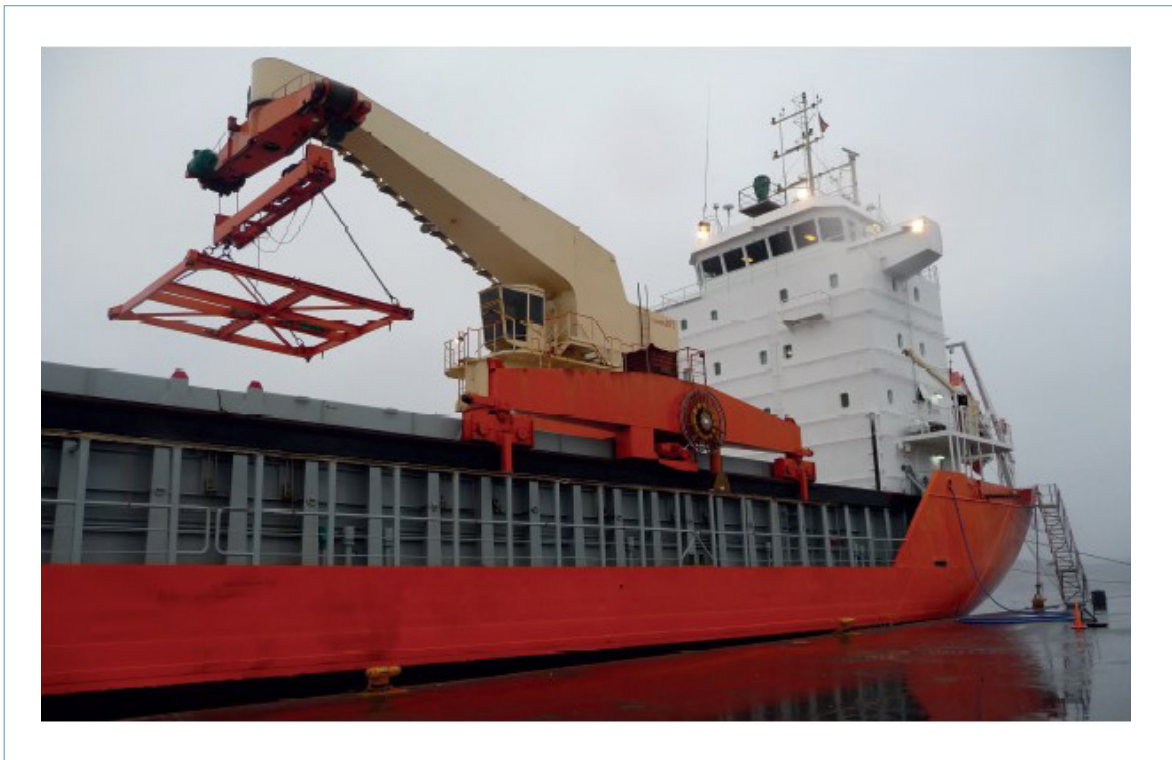
The Dutch cargo vessel Lady Christina was moored in the port of Rauma (Finland), where it had unloaded a cargo of China clay. After the unloading, the ship was cleaned by the crew. During the cleaning operations, the crane operator moved the hatch crane slowly over the hatch coaming, which was hosed clean from the crane (see figure 14). During the operations a deckhand was found dead in the port gangway. Nobody on board saw the accident happen.

Figure 14: Crane on board the Lady Christina. (Source: Dutch Safety Board)

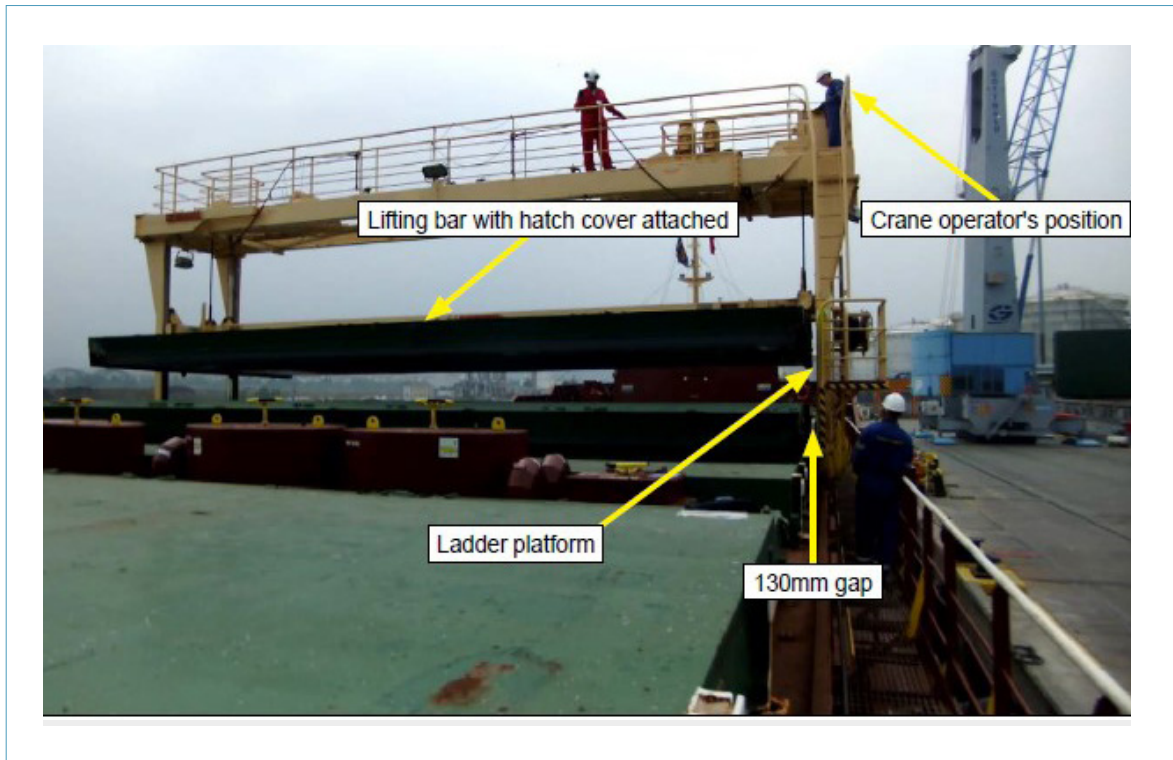
On 24 May 2019, a crew member on board of the cargo vessel Karina C in the port of Seville, Spain, got entrapped between a stack of hatches and the moving hatch crane. Earlier that day, the ship's agent had told the captain at 09.00 hours that the time of departure had been brought forward from 14.00 hours to 11.30 hours on that same day. At that time, the hatch crane was used to close the hatches.

Figure 15: Hatch crane viewed from the stern of the ship. (Source: MAIB)

After it became clear that the vessel had to depart earlier, the later victim went on deck to sweep up cement dust. This took place simultaneously with hatch crane operations. Shortly before the occurrence, the operator stopped the hatch crane near a stack of hatches at the same time the later victim was also there. The later victim then climbed on the hatchway coaming in order to step between the hatch crane and the stack of hatches. The crane operator did not notice this. At the same time the victim moved between the hatch crane and the stack of hatches, the operator started moving the hatch crane which caused the victim to become entrapped (see figure 16 and 17 for the MAIB reconstruction). The victim died of his injuries.
