# LESSONS LEARNT: NEAR MISS - UNPLANNED LIFT DESCENT

LOCATION: LIVERPOOL – CONTAINER TERMINAL, T2 STS CRANE QC06

Ref: LL 08 24

## Unplanned lift descent

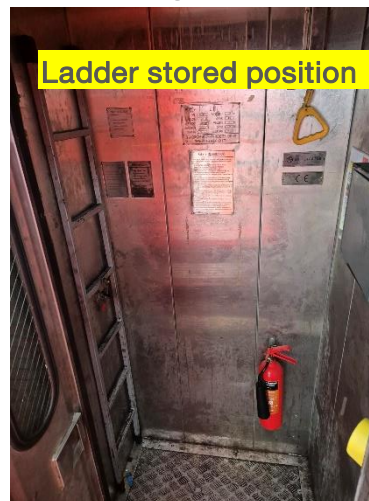
Image 1

The external engineers had packed the lift with too many people and one of them had inadvertently knocked the latch that secured the emergency ladder.

The external engineers had accidentally knocked the latch securing the emergency ladder inside the lift car. The shuddering of the lift ascending had caused the ladder to be released completely from the latch (image 1), falling forwards and making contact with the emergency brake release (image 2) which is designed to allow the lift to descend in situations where power is lost, and personnel are stuck inside.
