15 August 2026

# Safety Bulletin 8 /2026

## Crane wire damaged

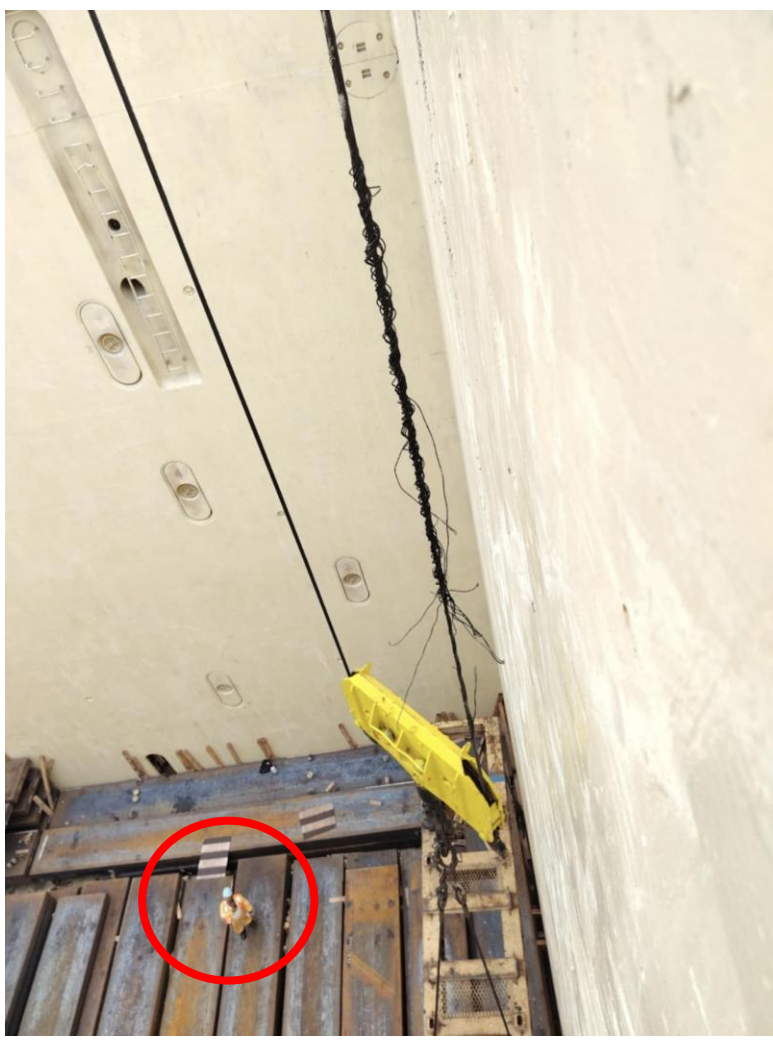
This cargo hold has an overhang, which increases the risk of the wire being dragged against the coaming. The crew has put up a mooring rope, to protect the bulkhead and alert the crane driver if the wire is too close.

- If you see the wire rubbing against the hatch coaming, hatch cover or any other part of the vessel: Stop the operation.
- There is no single measure which can eliminate the risk for all operations, but in most situations practical solutions can be found. Examples include:
  - Using a different size or type of lifting frame.
  - Using forklifts to re-position cargo inside the hold.
  - Protecting the bulkhead with mooring ropes.
